11th Meeting of the Advisory Committee

Report of the IWG on Protection of Overground Roosts

This draft report for discussion at AC11 deals in particular with protection of overground roosts in buildings of cultural heritage importance.

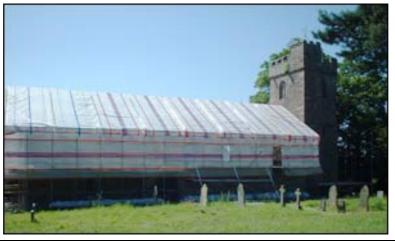
Three species of bat roost in St. Cadoc's church in Wales - *Rhinolophus hipposideros*, *Plecotus auritus* and *Myotis nattereri*. The church dates back to the early 1200s and is of considerable historical importance. In 2002 it was discovered that essential repairs to the roof were required and scaffolding was immediately erected to stop it from collapsing. No further works were carried out, however, until the bats had left the church in the autumn. At that stage a polythene tent was constructed over the roof to allow the restoration works to be carried out over the winter months with a view to having the building ready for occupation by bats again the following spring.

The work took longer than expected, however, and the builders were still onsite when the bats returned. Through agreement with the local SNCO [Countryside Council for Wales], work was able to continue on the main roof, but the tower where the bats roosted was left untouched during the breeding season. The bats successfully reared their young, despite the ongoing restoration works nearby, and the remaining works were completed over the autumn.

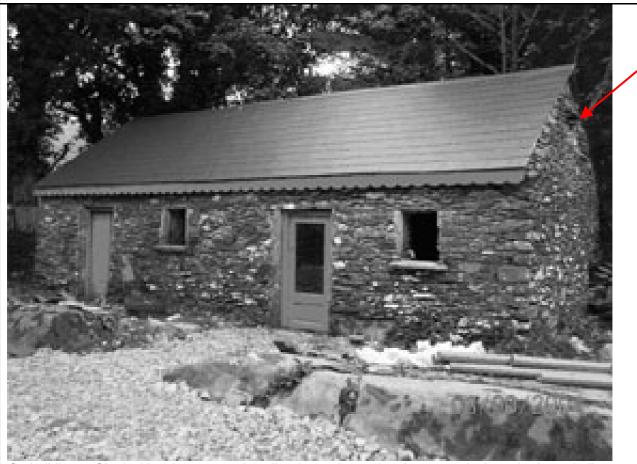
Outbuilding at Glaninchinquin renovated to allow lesser horseshoe bats roost in the attic. Arrow indicates access point made for bats into attic space.

The original roost had a count of 150+ bats in 2003, the year prior to disturbance, and c130 in 2004 after the roost had been gutted. The new roost was constructed at the end of 2004 and by May 2005, the bats had moved in. The peak count for the new roost in 2005 was c120. Bats were not able to enter the original roost by this time as all access points had been sealed.

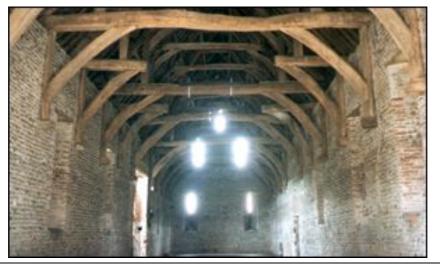
The barn has been subject to massive renovation over the last few years, including complete re-thatching, repointing, replacement of doors, and restoration of its associated buildings. A steering group, including BCT, English Nature, the local bat group and the buildings trust, has controlled restoration work at the site. Measures to minimise the disturbance to the bats have included timing of works out of the breeding season (though due to delays work sometimes overran), replacing doors with temporary structures while work was done off site, use of traditional materials and carrying out work by hand where possible. The roost spaces above the lintels, which were favoured by the Barbastelles, were maintained and the new doors were constructed to give continued access for the bats.

The collaboration of all parties and the sensitive nature of the works to date have ensured the continued use of this historic barn by the bats.
