12th Meeting of the Advisory Committee

Draft Report of the IWG on the Protection of Overground Roosts (particularly those in buildings of cultural heritage importance)

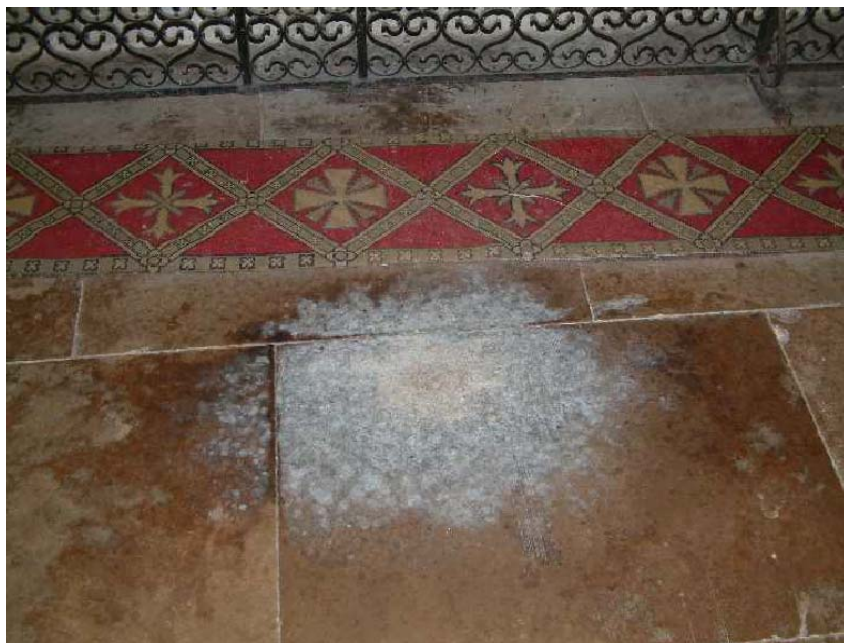
Picture XXX Damage to stonework at Penmon Priory, Wales due to long-term exposure to bat urine [photo: J. Matthews]

Droppings, over a protracted period of time, may cause pitting, long-term staining and etching to porous materials such as painted wall surfaces, wooden monuments and stone sculptures. Bat urine (which is 70% urea) is chemically more aggressive and therefore of even greater

conservation concern. It can cause spotting and etching of wooden, metal and painted surfaces (Paine 1993 & unknown year).

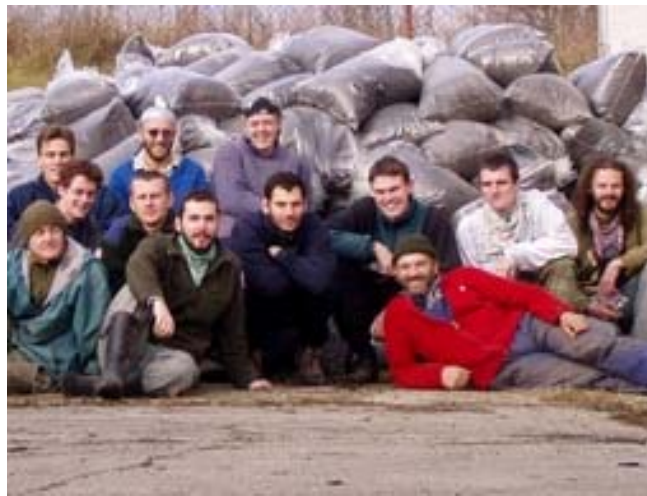
On 3rd and 4th of December, 2004, the loft of the church was cleaned with the help of the employees of the Muránska Planina National Park and Slovak Bat Conservation Group [SON] members. The guano was bagged and distributed to members of the local community as fertiliser. The colony continues to thrive and the ceiling of the church is no longer threatened with collapse.

The loft of the Lutheran church in the village of Ratková, Slovakia, is occupied by a nursery colony of *Myotis myotis* and *Myotis blythii* in summer. The colony was discovered in 1992 and is the biggest colony of this type known in Slovakia, with up to 5,000 individuals present. A thick layer of bat guano had accumulated below the colony over the years; in places the layer of guano exceeded 1 m. The weight of the guano was about 10 tonnes, giving rise to concerns about the ceiling of the church.

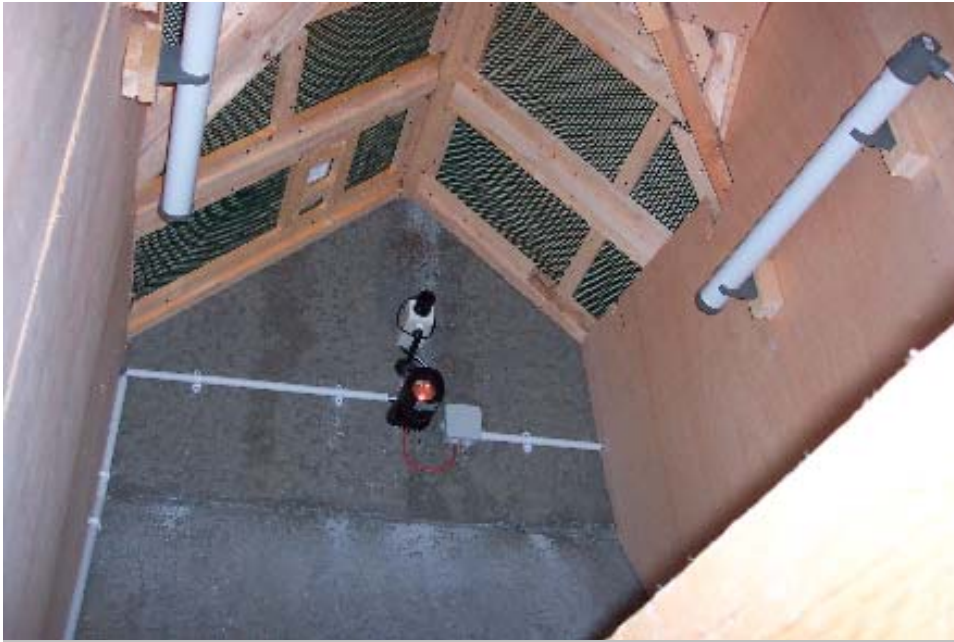
Fig XXX. Roof space modified as nursery area for lesser horseshoe bats with baffles and electric heaters on either side (and video camera for remote monitoring) Co. Clare, Ireland.

For maternity roosts, bats appear to prefer maximum daytime temperatures of between 30° and 50°C, so it is important that the roof receives full sunlight for a large part of the day. This can be assisted if the roof has two ridges at right angles, oriented to capture sunlight throughout the day. As an alternative, a combination of baffles and electric heaters can be used to produce pockets of warm air at the apex of the roof. This technique has been used successfully with horseshoe bats and would probably be suitable for other species as well.

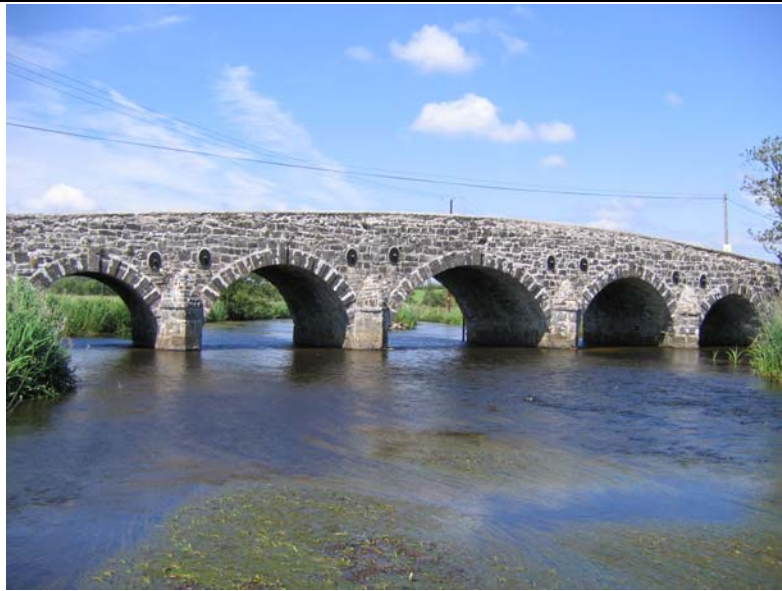
Fig. XXX: Lisconny Bridge, after restoration [©Caroline Shiel]

Lisconny Bridge is a beautiful five-arch masonry bridge spanning the Unshin River in north-west Ireland. It is as approximately 200 years old and in 2003 it was determined that the bridge was in need of major strengthening work. There was a large deep fissure running across two of the arch barrels. In addition, the bridge abutments were being seriously undermined by the river and were becoming unstable.

The bridge was known to hold a nursery roost of approximately 25 *Myotis daubentoni*. The roost was located in a deep fissure running across the barrel of one of the arches. Several other crevices were also being used by individual bats. A bat expert was employed by the local authority to work with the local engineer and with the contracting firm –Leamac Ltd, (an engineering company which specializes in the restoration of heritage bridges). It was agreed that 3-4 small crevices would be retained under each arch for individual bats. These were ring-marked with white paint before work began. It was also agreed that sections of the large fissure would be left open to accommodate the nursery colony.

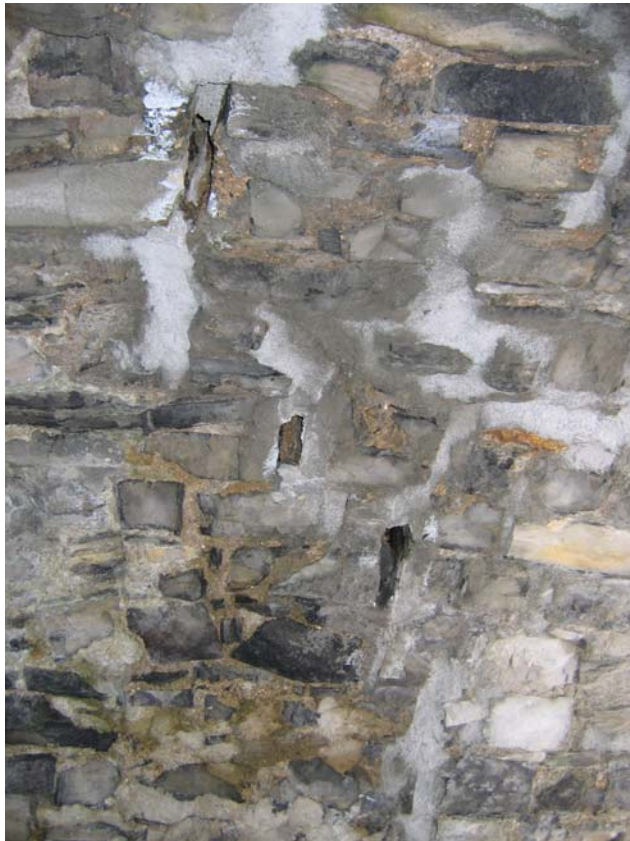
Fig. XXX: The three sections of the deep fissure that were left open to accommodate the nursery colony of Daubenton's bats. The nursery roost is located in the lowest section. Note how the stonework was carefully grouted around and not over.

Strengthening works commenced at the end of September 2003. This included the laying of new cement floors under the arches, pressure grouting to fill internal voids in the bridge and pressure pointing under the bridge arches. Prior to pressure pointing all crevices that had been marked for retention were blocked with polystyrene to prevent the infill of grout. Crucially, a fine nozzle was used to apply grout to the undersurface of the arches. The work was done carefully to fill in voids around the stonework so as not to cover the surface of the stones and not to spray over targeted bat crevices. Not only did this allow the bat crevices to be maintained, but it also retained the beauty of the bridge's stonework.

Works were completed by late October. In early July 2004 only 4 bats were recorded in the nursery crevice. However, most of the other smaller crevices which had been retained held single bats. In July 2005 a nursery colony of approximately 25 were recorded bats in the nursery site where they were first recorded in 1988. Lisconny Bridge is an excellent example of how bats can be accommodated during bridge strengthening procedures. But it also clearly illustrates that close liaison between a conscientious contractor and bat specialist is necessary both prior to and during strengthening works.

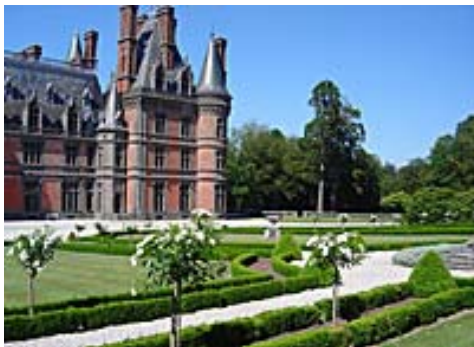
Fig. XX Ch. de Trevarez, Breton, France

A particular problem with some older buildings is the existence of lead based paints on girders or other metal structures. Bats can develop lead poisoning by ingesting flakes of this paint during grooming. Such a situation arose in the Chateau de Trevarez in north-west France. The chateau contained a nursery roost of 300 *R. hipposideros*. Lead poisoning was found to be the cause of high juvenile mortality at the site and in this case it was decided that the best solution was to build a new roost for the bats.
