IWG Bats, Insulation and Lining Materials DRAFT APRIL 2021

Contents

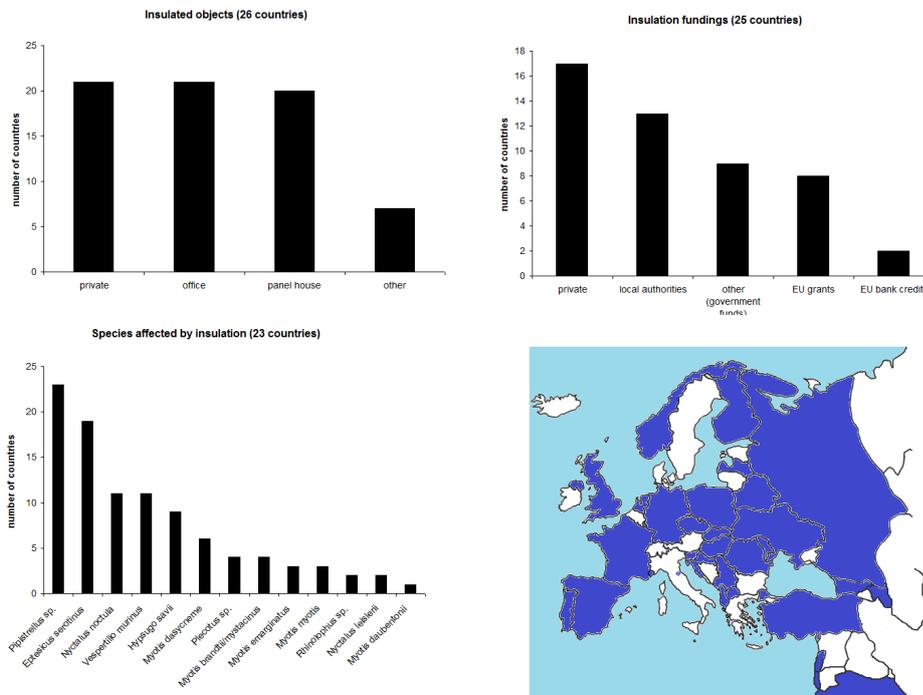
Fig.1. Bats and insulation – results from 31 questionnaires.

Most often insulated structures are private houses, office buildings and panel houses (blocks of flats); occasionally there are other buildings such as churches or monasteries. Most funding comes from private resources or local funds, but eight countries also use EU grants to finance their insulation programs. The most affected species are pipistrelles (*Pipistrellus kuhlii*, *P. nathusii*, *P. pipistrellus*, *P. pygmaeus*), noctules and serotine bats. In countries with panel houses the most affected species also include parti-coloured bats (fig 1.).

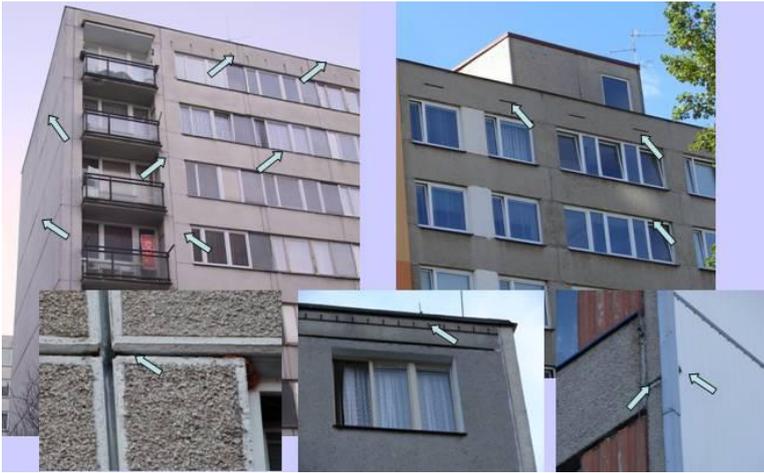
Fig.3. Example of bat roosts in not-insulated block of flats (Czech Republic; photo courtesy of ČESON).

Block of flats – fissures between panels, ventilation holes, space behind ventilation holes which lead to the space under the roof or into the pantry, ventilation shafts, crevice between

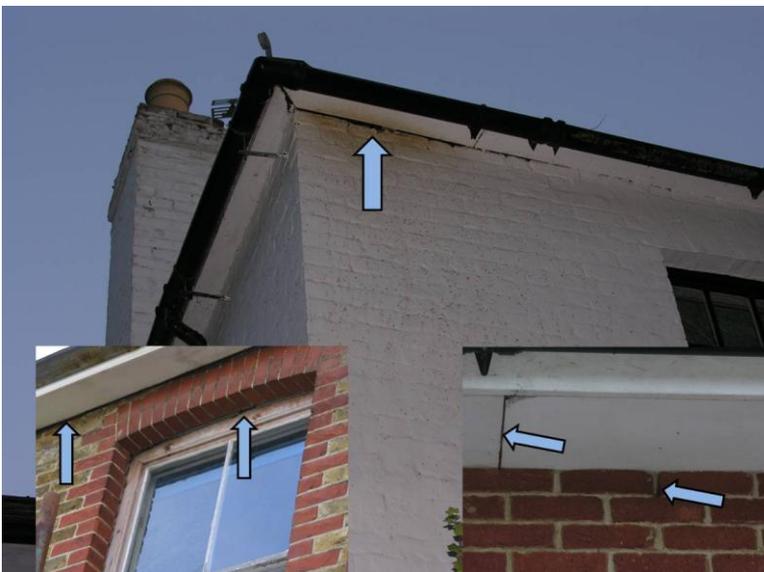
Fig. 4. Example of bat roosts in not-insulated house of rustic type (United Kingdom; photo courtesy of BCT/Shirley Thompson).

Other types of houses - crevices between bricks, crevices caused by mortar drop out, crevices under the roof, crevices under the lining, any bigger holes (in grilled entrances depends on size of grid or ablation of grill from surface), crevices under roofing tiles and timber, space between roofing tiles and old insulation or wall of builed-in attic room (fig.4).

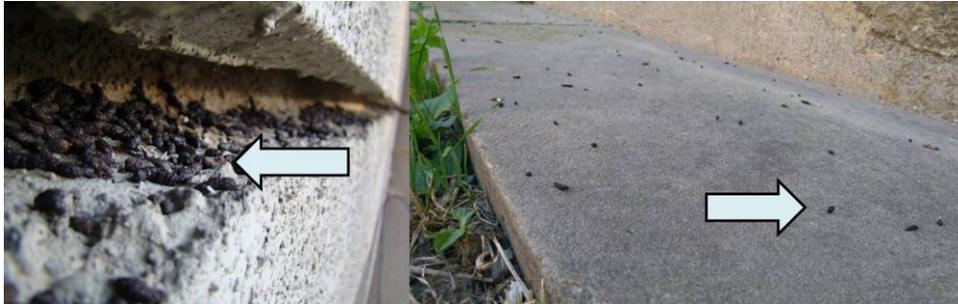
Fig. 5. Bat droppings (guano) between panels and in the gorund under the bat colony.

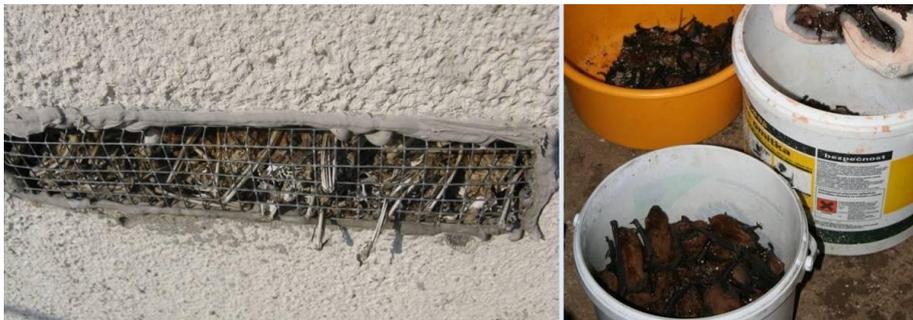
Fig.6. Left: Hundreds of bats entombed during renovation and insulation works. Right: Winter colony discovered during insulation was put in the buckets by construction workers and left to die.

Using this technique runs the risk of blocking all entrances to the roost, resulting in the **bats becoming entombed** inside the roost. Entrapment of bats when using polystyrene blocks can be sometimes revealed by strange bat behaviour – repeated landing to the freshly closed entrance, and inspection how to get in, probably because of silent, but still audible bat social calls. It is also possible that hibernating bats or maternity colony will be uncovered when parts of the roof are removed at the beginning of the construction works. There is not only a risk to individual **bats being harmed or killed** during insulation works, but also that the whole **roost** will be endangered. The use of insulation using polystyrene or glass fibre blocks is increasing markedly across Europe (fig.6).

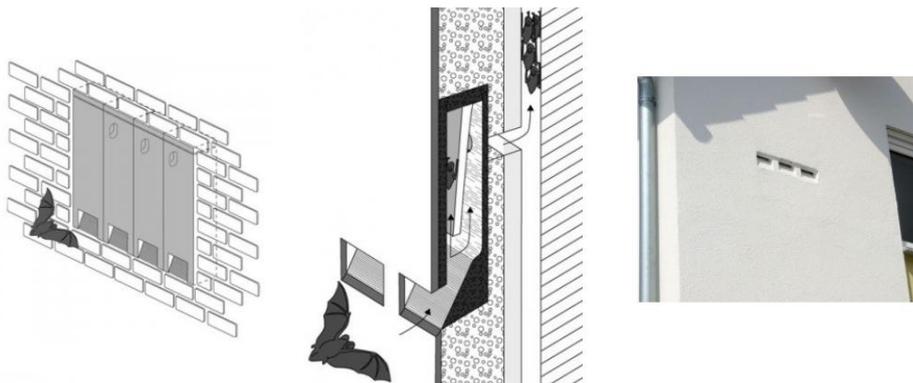
Fig.7. Installation of bat boxes, which save original roost after insulation. Nevertheless, after several years according to the size of colony, bat guano can concentrate in the original roost behind the insulation layer.

If it is technically possible to save the roost, it is recommended that a special 'passageway' bat box is installed to act as an access point for the bats; this has entrances on both sides and enables bats to enter the original roost after insulation. There are several types of wooden-concrete bat boxes or polystyrene bat boxes. They are usually 8-12 cm wide and can be very simply integrated into the insulation layer. In some cases it is necessary to underlay or cover them (ensuring that gaps are left uncovered) with insulation material to fit the smooth surface of facade. The method of fixing them depends on the type of bat boxes; they can be glued in

the same way as polystyrene blocks or they are secured using metal plates and screws. The surface of boxes should be covered by gauze fabric and can be painted the same colour as the rest of the facade. Once the works are completed, only the entrance of the roost is visible. These types of transit bat „access bricks“ boxes are used successfully in Germany, Czech Republic and Slovak Republic (fig.7).

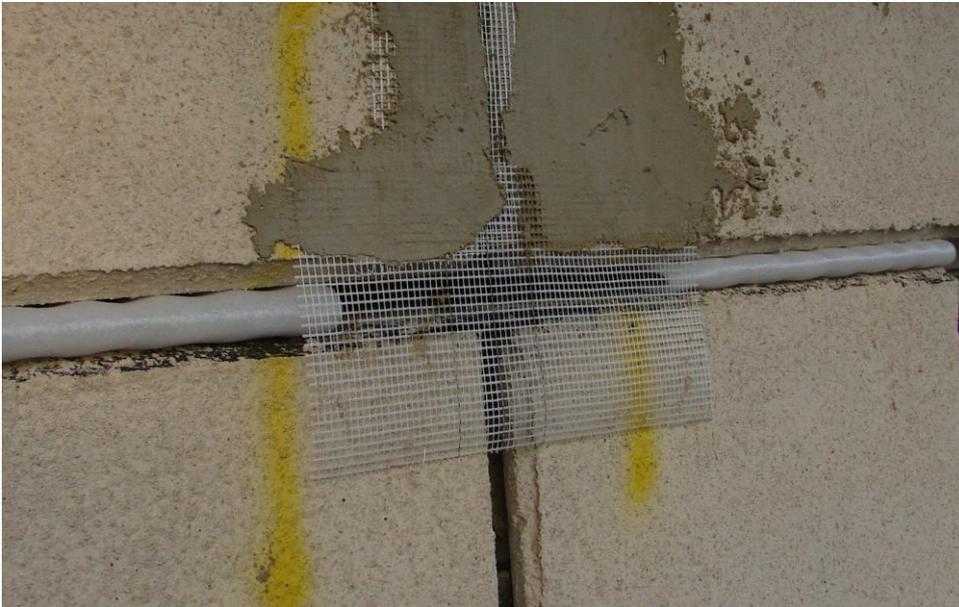
Fig.8. Exclusion flap allows bat to leave the roost but prevents return. The flap is fixed on the top and it must closely cover the whole entrance and not stand away from the wall. Photo courtesy of Petra Schnitzerová (ČESON).

If it is technically not possible to save the roost, it is necessary to ensure that all bats leave the roost prior to the covering of its entrance. This method can not be used during period when bats give birth and raise their offsprings and in the hibernation period. At least a week prior to works, the square „**exclusion flap**“ made from soft wire grid (mesh should not be bigger than 0.5mm) should be placed over the entrance and fixed only at the top (fig.8). It is also possible to use a firmer plastic square. Three sides of the square remain free, but should not stand away from the wall. This one-way enclosure made in correct way enables bats fly out from the roost, but does not allow them to return back. Similarly a metal or plastic tube can be used (length 20cm, diameter a bit more than 4 cm but not much bigger, according to the bat species), to fasten to the roost entrance, angled downwards. The slope, diameter and smooth surface of these tubes prevent the bats returning. It is necessary to ensure that bats do not enter the roost by different entrances, e.g in long fissures. The one-way enclosure can not be there for long time (more months), because weather changes, wind and other circumstances lead to the deterioration and its function is reduced. Loss of the roost should be compensated by placing bat boxes close to the previous roost (see chapter 4.6).

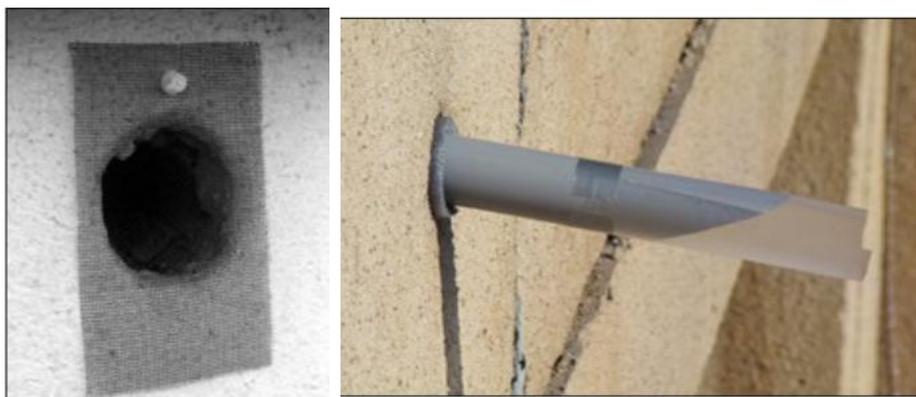
Fig.9. Exclusion flaps covering ventilation hole and variation of exclusion flap - a sloping plastic tube with at least 4 cm in diameter. The plastic cover around the tube prevents entering by bats or swifts. Photo courtesy of ČESON and Martin Ceľuch.

a) the insulation plan includes only insulation of the walls of the building and not the roof. In this case it is necessary to keep all ventilation holes open. During insulation, holes must not be covered by insulation even for a short time. Circle openings in insulation are usually provided with plastic end covers to prevent rain and water leaking in, but often they contain grids or horizontal plates. Such plastic end covers must be modified to allow bats enter the roost (e.g. remove horizontal slats). The lower edge should be rasped to ensure it is sufficiently rough for bats to land and hold on to. Instead of using a plastic end cover, a plastic tube that has a diagonal cut at the end (so the upper part forms a ‚roof‘, see figure below) could be placed at the end of the vent plastic tube. The inner parts of this plastic tube must also be rasped to help bats crawl in and out. The diameter should be at least 6 cm to be suitable also for swifts, which use similar roosts and in smaller diametres they can stick (fig.10.). Rectangular horizontal openings should be equipped with a ‚roof‘ made from a metal plate fixed on the previous wall before the insulation material is laid. A plastic rough plate should be fixed to the lower edge of the opening. A similar approach should be taken

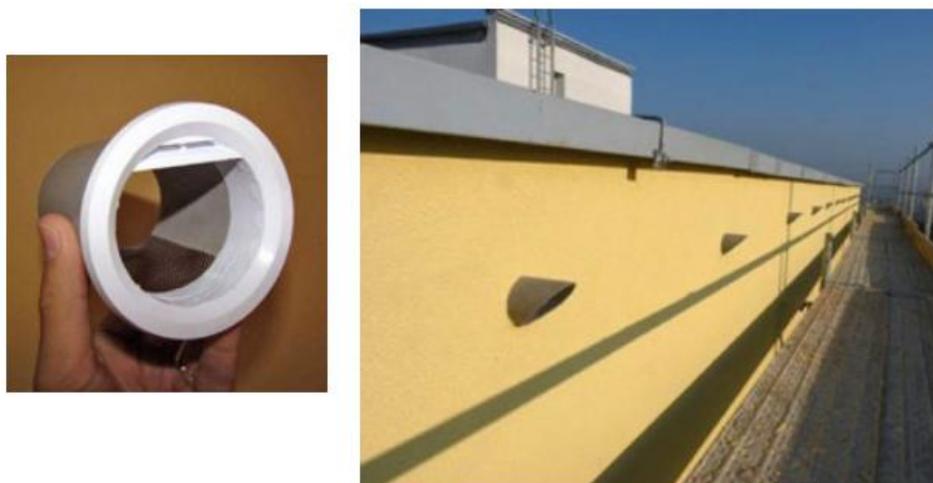
Fig.10. Covers of ventilation holes were modified to serve both bats and swifts. The diameter is at least 6 cm. Photo courtesy of Martin Ceľuch and Lukáš Viktora.

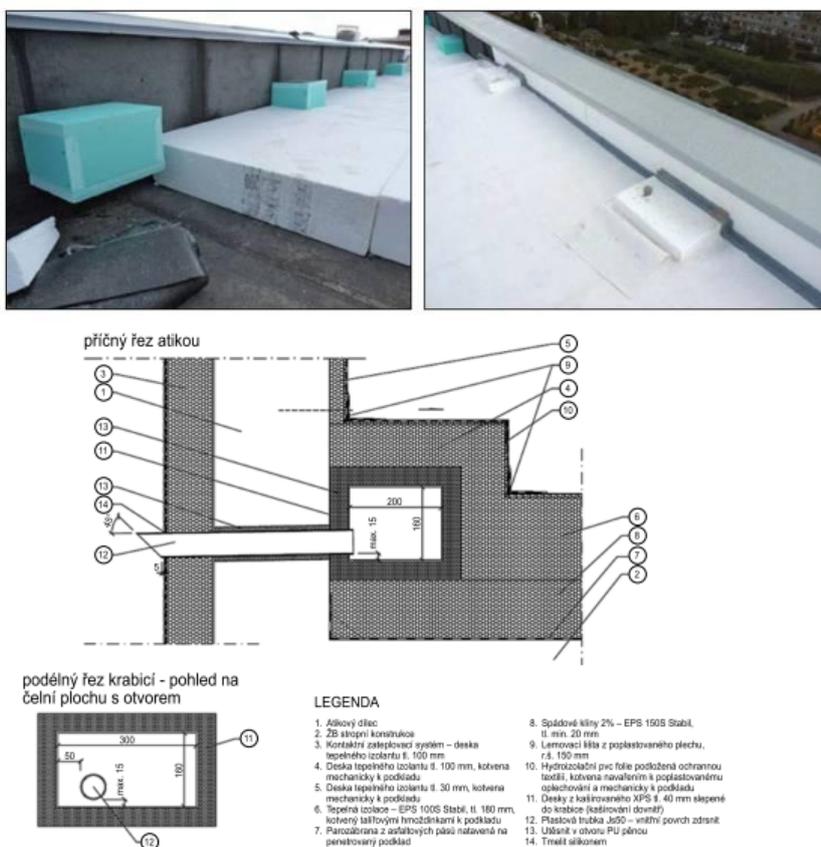
Fig.11 Insulation and reconstruction of the roof. The roof was changed from a ventilated to an insulated roof, which led to destruction of all cavities. One possibility is to make artificial cavities. Photo courtesy of Lukáš Viktora and Ivan Řehoř.

c) the insulation plan includes the insulation and reconstruction of the roof, which should change from a ventilated to an insulated roof. In this case all cavities are filled with insulation material. Works must be timed appropriately as per the previous examples, and before work is started, it must be established that all bats have left the roost. The one-way enclosure method described above is used in this case. The loss of the roost needs to be compensated by placing bat boxes close to the previous roost (see chapter 4.6). It is also possible to install bat boxes inside the roof wrapped in insulation material which lead to ventilation hole or a more exacting method of digging new artificial cavities into the panel. These methods can only be applied in some cases, where the heat audit of building stays unchanged. Parameters of artificial cavities should be at least 30 x 15 x 15 cm with entrance 4 x 7 cm, but the real parameters should be adjusted to the concrete house (fig.11)

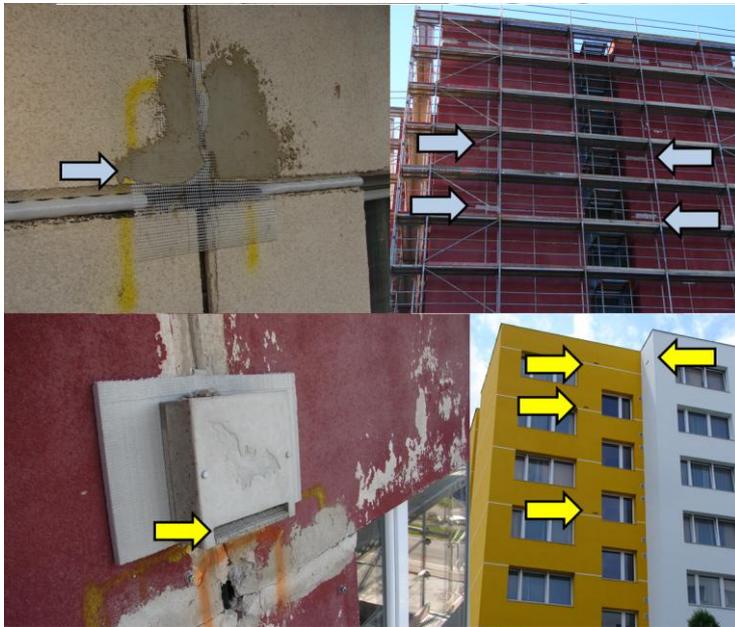
Insulation of typical panel house and mitigation measures in Prešov city, Slovak Republic. Solved by members of SON (Slovak Bat Conservation Society)

Insulation works were realised from March to September 2014, because it was a massive building. Attic with active nests of swifts was kept open until last nestlings jumped out. Nests in the crevices were found by inspection from scaffolding, marked and free space around them was left.

It was not possible to keep the attic openings or crevices between panel open, because there will be to high thermal loss. Nest places of birds and bat roosts were replaced by XPS polystyrene boxes type BAT-MAN APUS-4 and BAT-MAN APUS-3. For swifts and sparrows altogether on three walls 112 nest boxes were installed. For noctules 8 double chamber boxes of type BAT-MAN Maxi-B were installed.

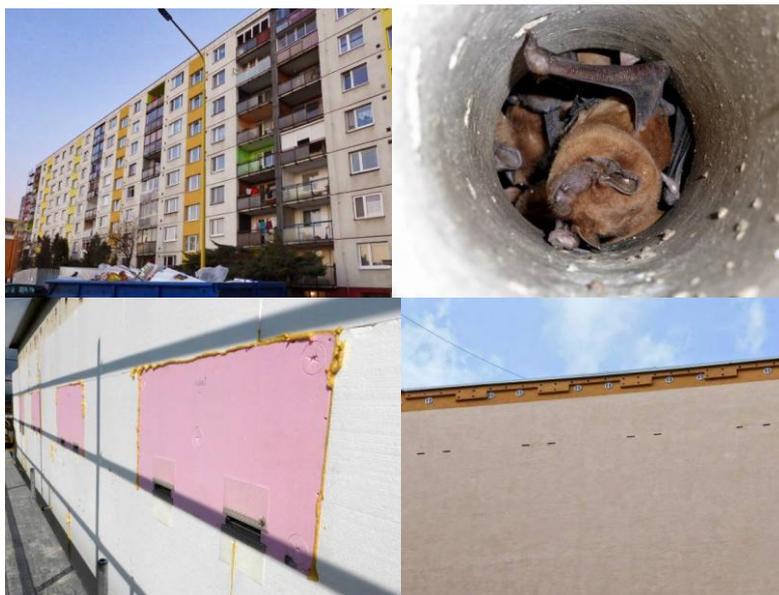
Most of the boxes were installed on side walls without windows, to lower the impact of animals and falling bat guano from boxes on dwellers. We have big concentrations of noctules in buildings and their sounds and guano makes problems to people.

Boxes were used in the upcoming winter by bats and next year also by first breeding pairs of swifts. Adaptation of swifts on new boxes takes usually more time than by noctules. Hundreds of such building were realised in similar way all over in Slovak Republic and similar mitigation measures were taken successfully.

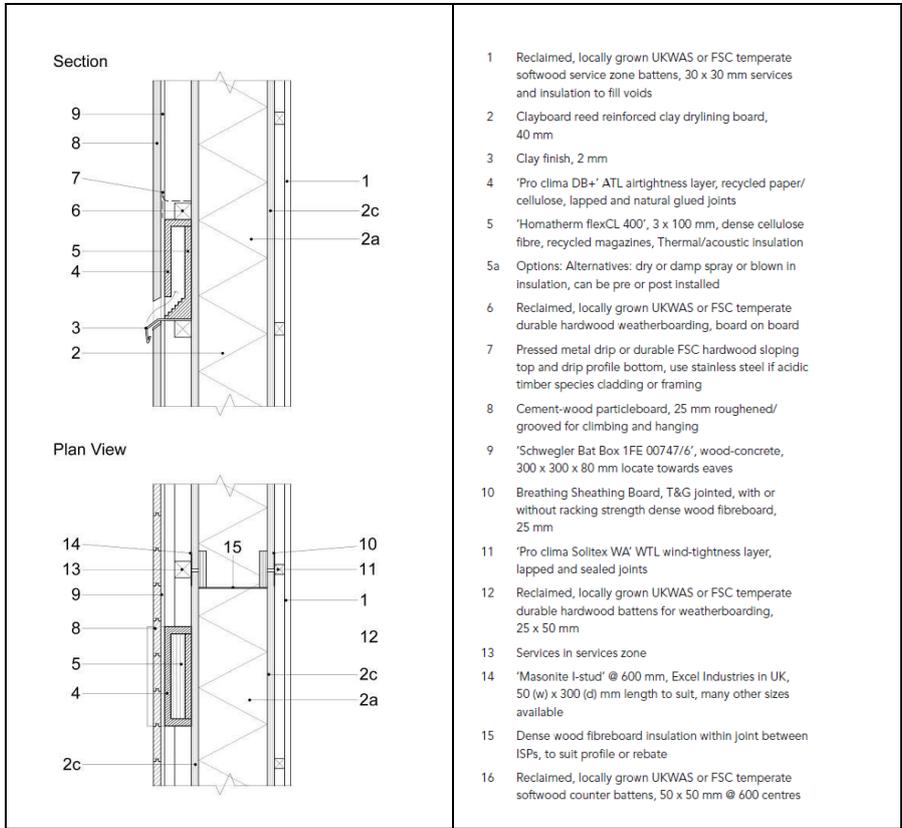
- 1 Reclaimed, locally grown UKWAS or FSC temperate softwood service zone battens, 30 x 30 mm services and insulation to fill voids
- 2 Clayboard reed reinforced clay drylining board, 40 mm

- 7 Pressed metal drip or durable FSC hardwood sloping top and drip profile bottom, use stainless steel if acidic timber species cladding or framing
- 8 Cement-wood particleboard, 25 mm roughened/grooved for climbing and hanging

The current solution is to place a built-in bat box in the newly installed outer walls and leave small spaces. Work in the most vulnerable periods (maternity season and winter) is only undertaken when there is certainty that hibernacula or maternity roosts are not present. If work has to be done in these two periods, measures are taken to prevent bats from using the roosts. Prior to starting work measures are always taken to prevent bats from using the roosts and to remove bats from roosts. Measures considered are opening the original outer wall to expose the wall cavity to make an unfavourable climate for the bats. Exclusion flaps and/or filling gaps are also used, but only in period when non-volant juveniles are not present. The project should be discussed with the architect (fig.12).

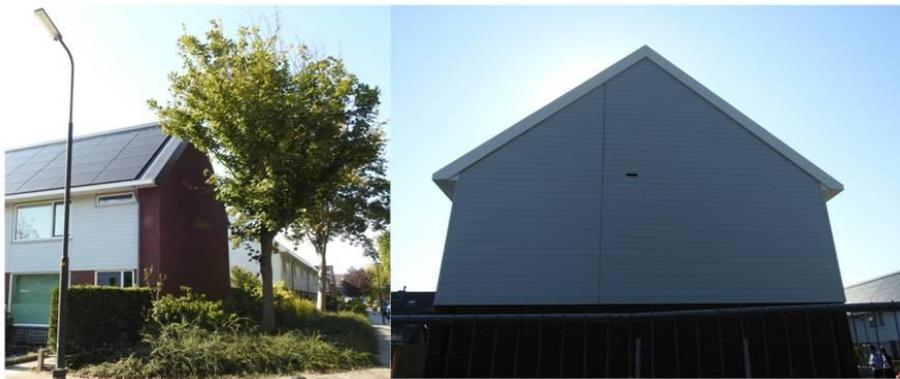
Left: House with completely new outer walls and roof (note solar panels as well). Right: Entrance to a large built-in bat box is visible in the new outer wall.

In this country, most of the insulation works are undertaken using rapid rate by wall to wall insulation. To prevent groups of bat casualties the maternity season is avoided for works, and if this is not possible for some reason, measures are taken to prevent bats being present in the cavity walls. Other mitigation measures are always undertaken, e.g. large built in batbox, and leaving several small spaces for bats, irrespective of whether or not bats are present. A so called 'surroundings check' evaluates whether the standard measures are adequate. The 'surroundings check' is heavily based on existing data, which is not thorough as there are a lot of areas where there is no data present. Both the Dutch network of ecological bureaus and several NGOs have strongly protested this approach. They fear the 'surroundings check' is not complete enough and state that measures taken are not proven to work for species other than common pipistrelle.

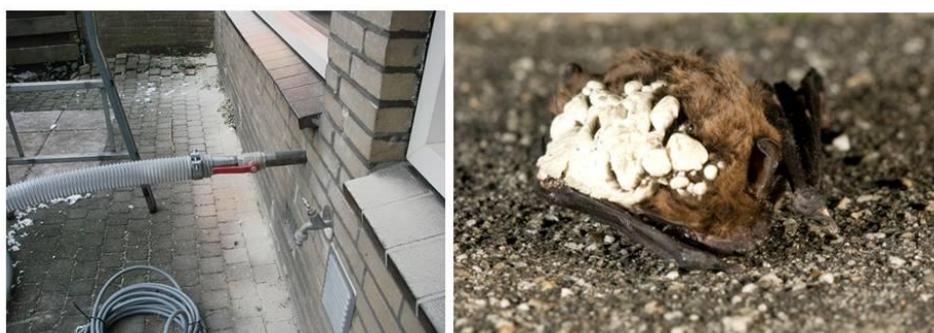
Fig.13. Example of filling up cavity wall and a bat victim of polyurethan (PUR).

- Blown mineral wool (glass or rock wool). It consists of mechanically granulated spun glass or rock wool, treated with a binder or water repellent during manufacture.
- UF Foam. Urea Formaldehyde Foam is injected into the cavity in a wet foam state 90-95% pre expanded through 19mm holes. It completes its expansion by moulding itself to the unusual shapes within a cavity and sets to form a rigid insulant.
- EPS beads. The expanded polystyrene bead used for cavity wall insulation is in the form of virgin pre-formed bead which are usually combined with a binding agent or adhesive at the time of injection. Polystyrene beads are produced to a specified size and density which remains unaltered during the installation process.

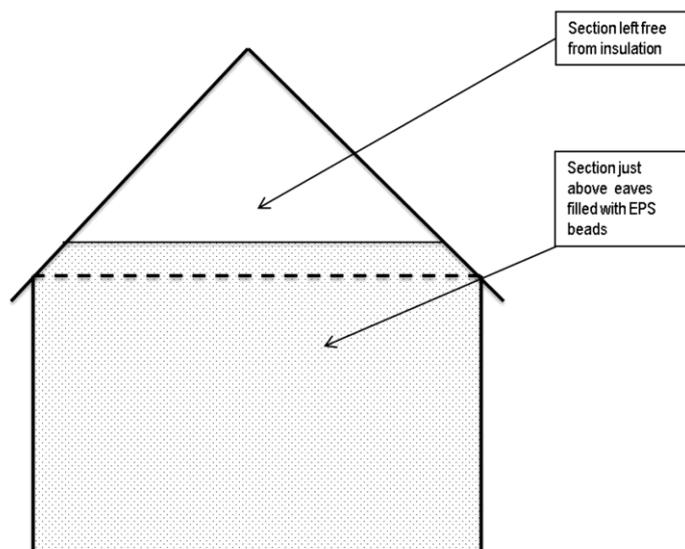
Fig.14. Retaining a section free from insulating material. Photo courtesy of BCT.

To avoid entombing bats in cavity walls it is advised that works are undertaken only when outside temperatures are 10° C or above and that insulation should start from the bottom of the cavity wall and work upwards, thus giving any bats still remaining in the wall a chance to wake and escape. If the roof void is left as a cold space then the insulation fill stops at the eaves line and a gap at the top of the cavity wall is naturally left for bats. If any evidence is found of bats using the cavity walls, advice must be sought from a specialist. He should suggest on this concrete case the best way to retain a roosting site and ensure the building is insulated properly. Often, external bat boxes are used in such cases.

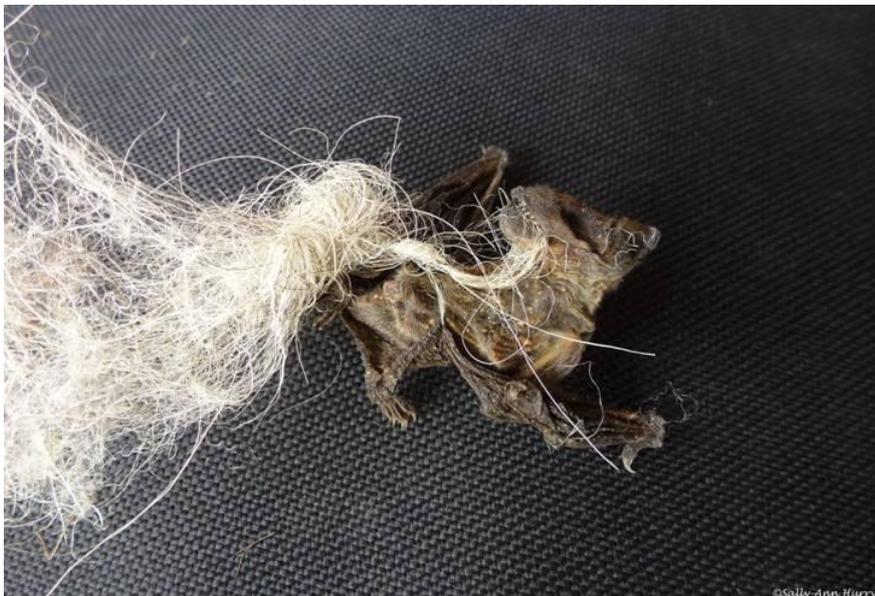
Fig. 15. Sheep's wool insulation wrapped around a serotine pup. There were a total of three deceased pups tangled in the insulation fibres. The roost is monitored each summer and the max. count is around 25-30 bats, in winter the roost is cleaned to minimise the droppings for the roost owner and gives an opportunity to check there are no further issues with the insulation. The insulation is now covered over with dust sheets to prevent bats getting tangled and there haven't been any further problems since doing this (Credit - Pers.coms. Sally-Anne Hurry, Mountfield Ecology)

Bats are threatened by entnglement. The wool strands become loose and beome tangled around a bats' feet and wings, resulting in bats becoming immobilised and eventually dying (fig.15).

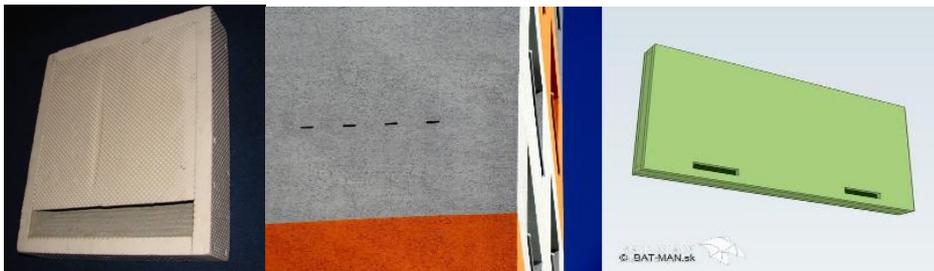
Fig.16. Example of polystyrene bat boxes to the insulation layer (JIZECO, CZ and BAT-MAN, SK).

the bats a better grip and protects the box from wearing. In the winter they use residual heat from the building to keep thermal conditions stable around 6 °C. They are successful for wintering of noctules, for example box type Maxi-B for 50-100 noctules. If they are heavily used by noctules, there could occur staining under the box from bat guano and urine.

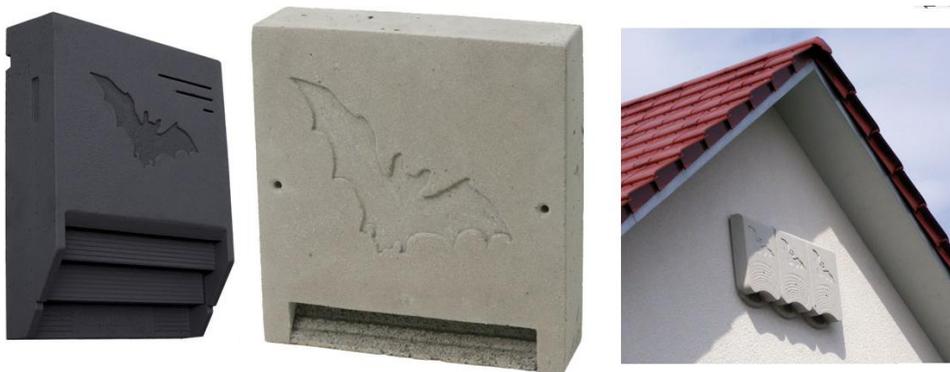
Fig.17. Different types and design of non-passageaway box (courtesy of Schwegler).

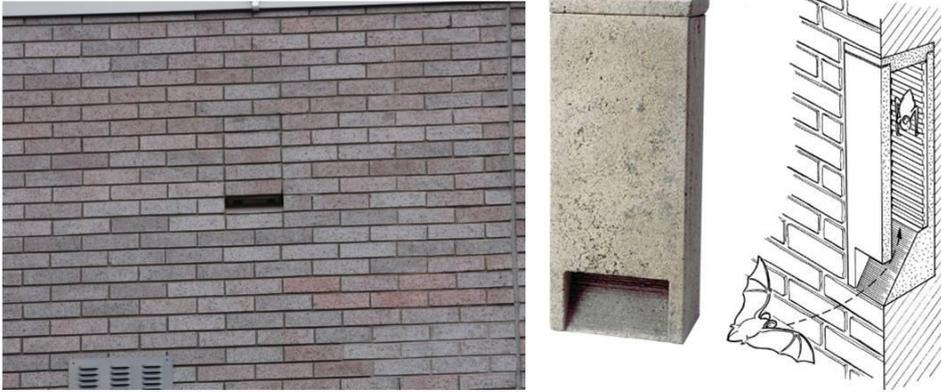
Fig.18. Left: Habitat integrated bat box in grey brick © Graham Jeffery / BCT. Right: Inside facade bat box (courtesy of Schwegler).

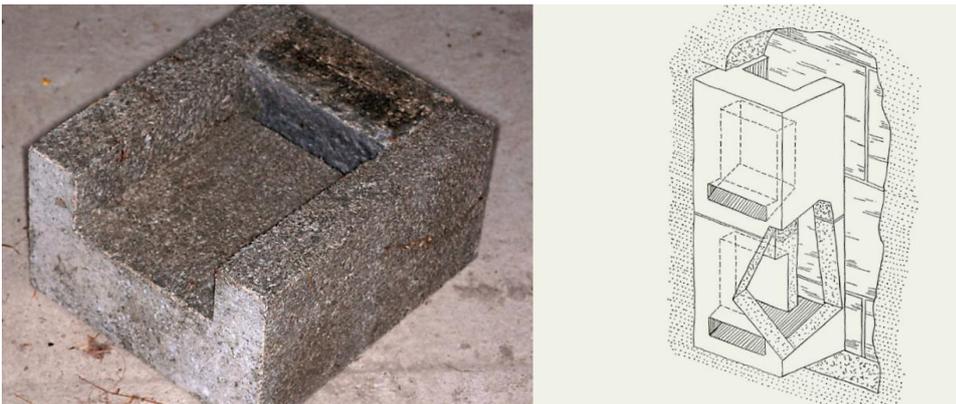
Fig.19. Passageway bat box (courtesy of Naturschutzbedarf Strobel).

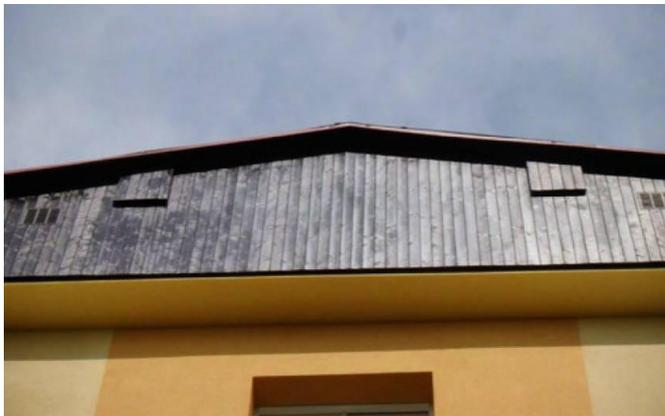
Fig.20. Use of the wooden boxes in the facade of the newly insulated school (photo courtesy of Evžen Tošenovský).

Wooden bat boxes are used only on facade in specific cases, especially when is on the building wooden lining and the bat box imitate the roost.

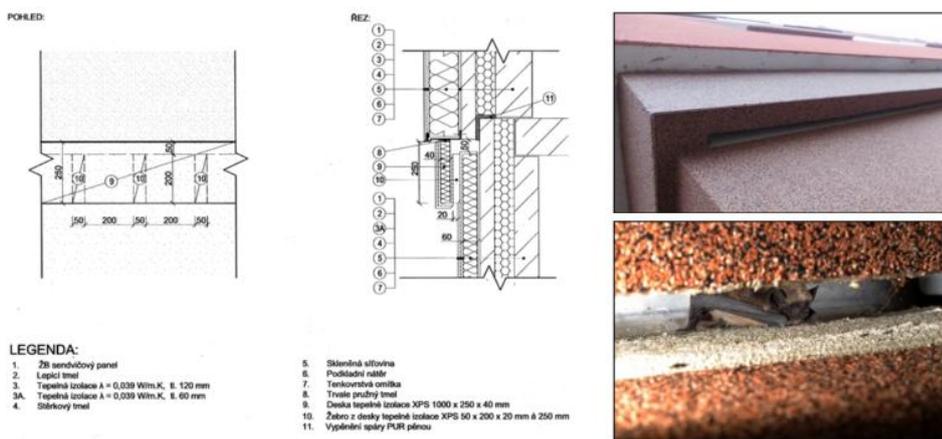
Fig.21. Example of new artificial bat roost in insulation house simulating the crevice roost in fissure between panels (photo courtesy of ČESON).

If it is possible to make an artificial bat roost which resembles the original roost in both design and physical conditions (temperature, humidity), it should be used for specific cases. This solution can prove much more effective than commercial bat boxes, but it is often more complicated. The type of new roosts on buildings, even the more unusual solutions, should be recorded as a case example so that others can get inspiration (fig.21).

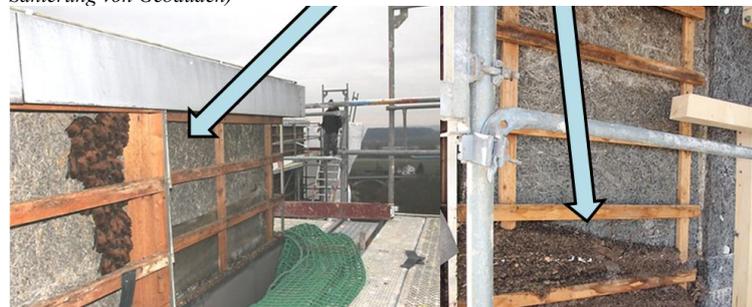
Joined system of roosts in noctule bats in Waldkreiburg, Bayern, Germany.

Buildings in Bayern are very important noctule bat hibernacula in winter, but individual bats roost in crevices and under the cladding of walls and roof throughout whole year. In case, bats use hibernacula for many periods, guano can accumulate under the colony inside the building. There is so far no evidence of maternity colonies during early summer. The roosts were known from 12 buildings which were relatively closed each other and form one joined system of roosts. During insulation works, roosts on 11 buildings were destroyed. As a mitigation measure, 31 bat boxes or substitutive roosts were made. One half of them have entrance at the same place. In the first phase of construction works bats inhabited only unchanged roosts, but after losing 70% of roosts they started to settle in a new bat boxes on facade or inside insulation. About one third of roosts was inhabited during following three months. During observation was discovered, that noctule bats have problems to find the opening entrance of the new bat box and problems increase according to distance of the previous roosts (*Hammer, M., Zahn, A. Fledermäuse trotz Wärmedämmung ? Artenschutz im Rahmen der energetischen Sanierung von Gebäuden*)

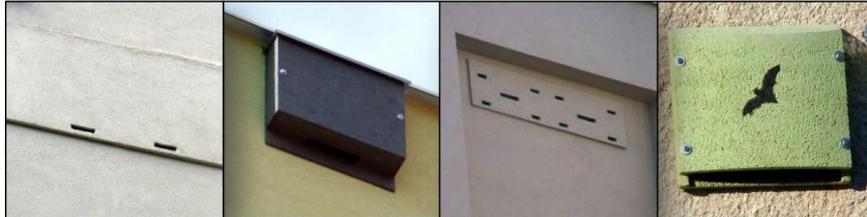
Post-insulation survey and bat boxes efficiency, Slovak Republic

Occupation of boxes installed during renovation of building in years 2012-2015 was surveyed in the year 2015 (Cefuch et al. 2016). Altogether 526 bat boxes (chambers) were checked on 90 localities in 3 regions in Slovakia. In the survey 4 different types of bat boxes were used – polystyrene Maxi-B, Hibernation box (insulated box from OSB board and polystyrene insulation), UNI-XL and woodconcrete box Strobel Nr. 128. Hibernation box and wood-concrete boxes were installed on the insulation, polystyrene boxes into the insulation layer.

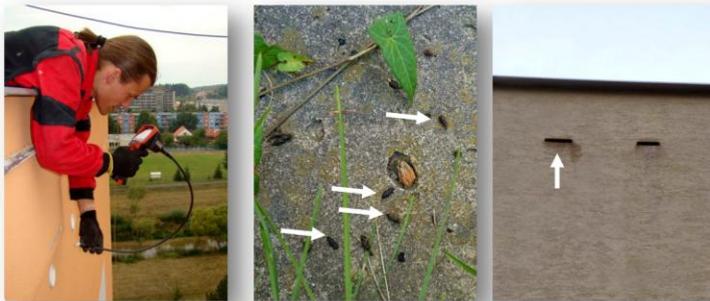
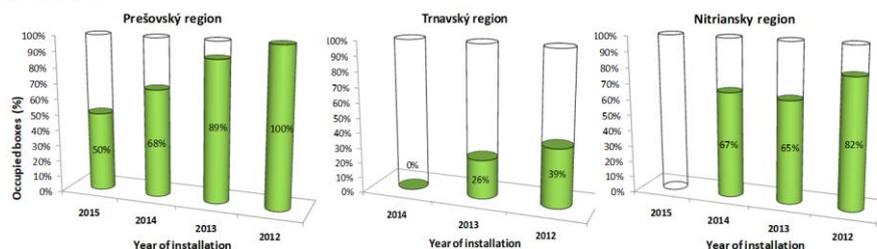
In the year 53 % of 526 installed boxes were occupied by bats, mostly noctules. Polystyrene boxes installed into the insulation layer were used also for hibernation, woodconcrete boxes only in autumn and spring because they freeze in the winter. Hibernation boxes were used also in winter. Occupancy was high - 100 % after 3 years from installation in Prešovský region and 39 % in Trnavský region. In this region (Westers Slovakia) there is lower occurrence of noctule bats. On some localities also boxes installed for swifts were used mostly in Prešovsky region. They have round opening and bigger chamber – so are attractive in smarming and mating time for noctules.

Temperatures in boxes were different. Outside temperature during January-February 2016 changed from +11°C to -15,5°C, mean temperature was 0,1°C. Mean temperature in the Hibernation box was 1,9°C, but ranged from 12°C to -8°C. Mean temperature in polystyrene box Maxi-B inside the insulation was 5,8°C, extremes were 12°C to 0,4°C. Interesting was, when temperature dropped under -15°C, bats woke up in both types and heated the box actively. Polystyrene bat box Maxi-B is more stable and more suitable for hibernation.
