A Review of Purpose-built Roosts for European Bats

H Schofield, A. Alagaili, M.-J Dubourg Savage, T. Kervyn, F Marnell, L. Rodrigues,

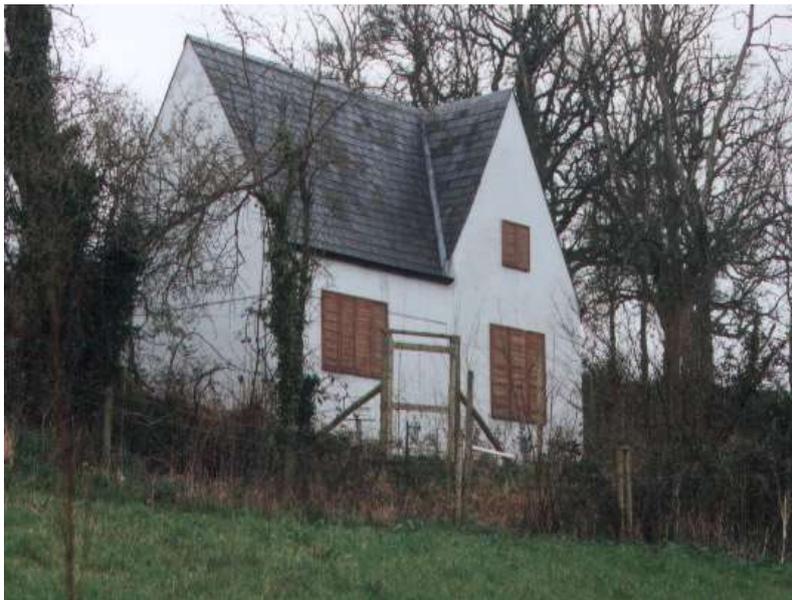
Figure 1. Bellaire Bat House. The false shutters were added to this building after construction to make it look less conspicuous.

The first of these bat houses to be built in Britain was in 1998, a new road development in southern England ran close to a small deserted cottage, which was found to contain a colony of less than 20 *Rhinolophus hipposideros*. The roofing slates had been partially removed and the building was in danger of collapsing and had to be demolished. The new roost was constructed some 100m away, similar in size to the original roost, the new building was constructed in an L-shape to improve the solar gain to the roof, which was also steeply pitched to create a wide range of temperature gradients inside for the bats.

The destruction of the original roost before the new bat house was constructed led to the colony deserting the area. It was two years before *R. hipposideros* started to use the building in small numbers and 11 years before a relatively substantial colony of over 60 bats were using the roost. The total cost of this building was £70,000.

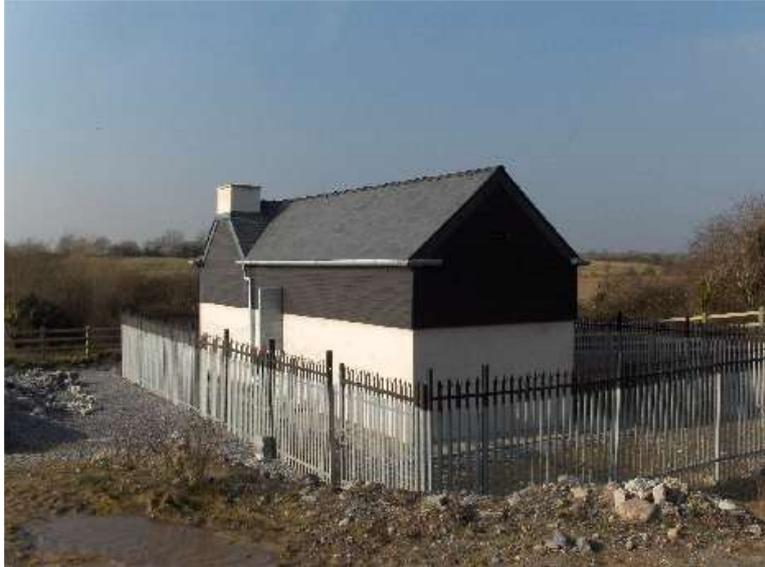
Figure 2. The Ennis bat house shortly after construction.

A more ambitious bat house for *R. hipposideros* was constructed near Ennis in the west of Ireland in 2005 as mitigation for a housing development. The building was 14m long and 8m high and made provision for a maternity roosting area in the roof as well as a hibernation area in the basement. It

was built some 400m from the original roost, which contained a small colony of only 5 bats. Take up of the building by the local population of *R. hipposideros* has been very limited. After seven years only two bats were recorded hibernating in the site and one was observed in the roof void in the summer.

The reasons cited for the lack of uptake have been the potentially small population of *R. hipposideros* in the area and the availability of other suitable roosts. However, problems in the original design may have also contributed with the building lacking the humidity required by hibernating bats due to the floors having an efficient damp-proof layer. Some subsequent modifications have been made to the building and it continues to be monitored.

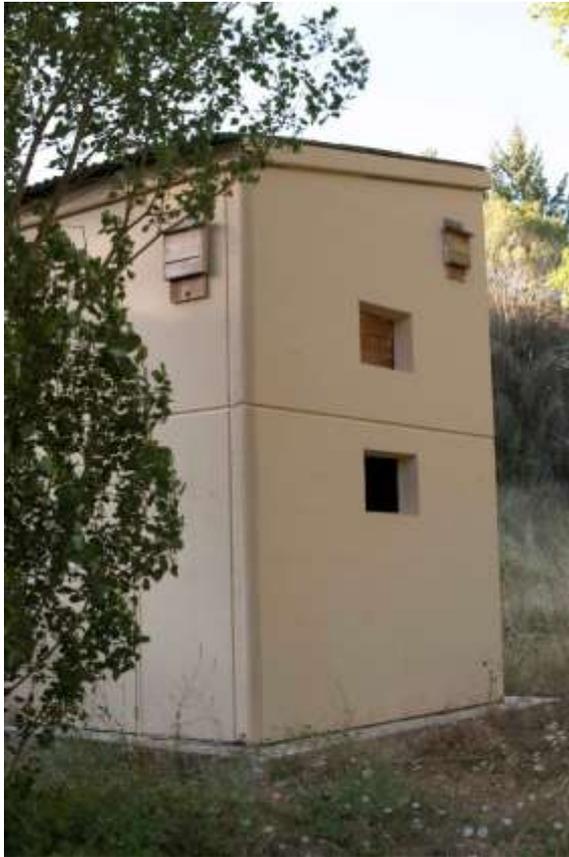
Figure 8. The larger R. ferrumequinum roost made out of two sections.

The new sites were constructed of pre-formed concrete sections manufactured off site. The larger of the structures was 2.6m square and 4m high, the smaller was 2m square and 3.2m high. Both had smooth exteriors and rough interiors, wooden boarding was attached to the ceiling in areas to provide extra purchase for the bats.

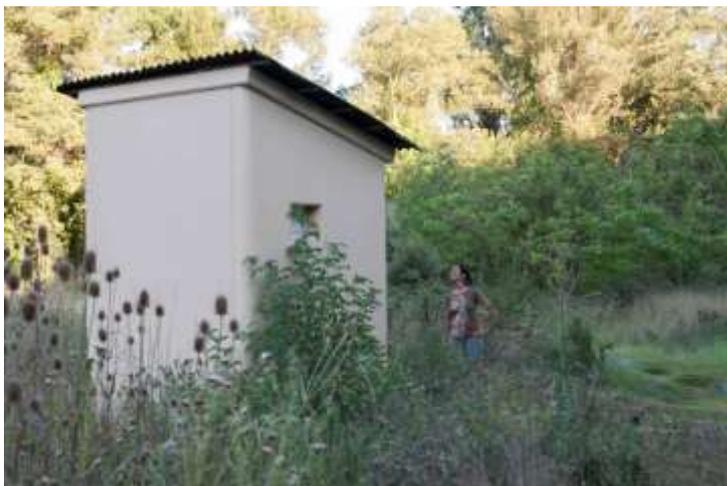
Figure 9. The smaller R. hipposideros roost.

Both new roosts have been successful with the larger site have a colony of 48 *R. ferrumequinum* and the smaller one 33 *R. hipposideros*. The *M. emarginatus* colony has also taken up residence in the larger of the two structures, although the numbers here have dropped from 200 down to 91 bats. Modifications were made to the buildings following the first year of monitoring, as evidence suggested the sites were over-heating and causing the bats to abandon them in hot weather. The exterior surfaces were treated with heat reflective paint and the roofs were modified to provide an air gap between the outer metal lining and the concrete ceiling. Both of these actions have reduced the extreme temperatures in the buildings and there have been no further abandonment of the roosts.

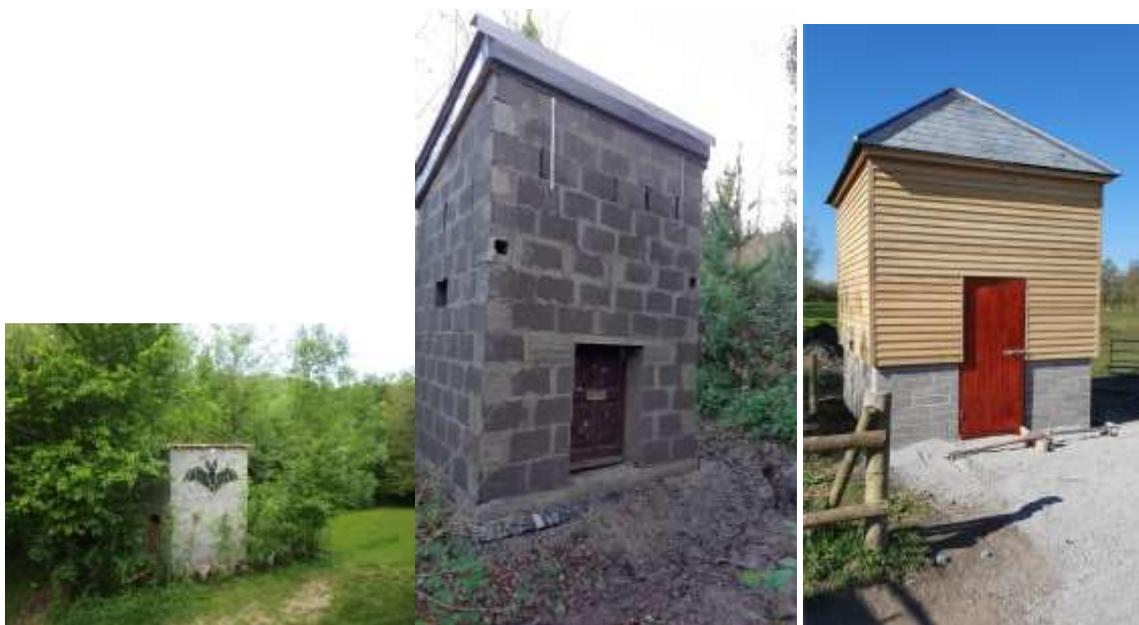
Figure 10 Bat towers constructed for *Rhinolophus hipposideros* in France (left) Ireland (centre) and UK (right)

Following these successes in Spain, the idea of bat towers for Rhinolophids has been trialled successfully in France. These structures have also been built in Ireland and the UK.

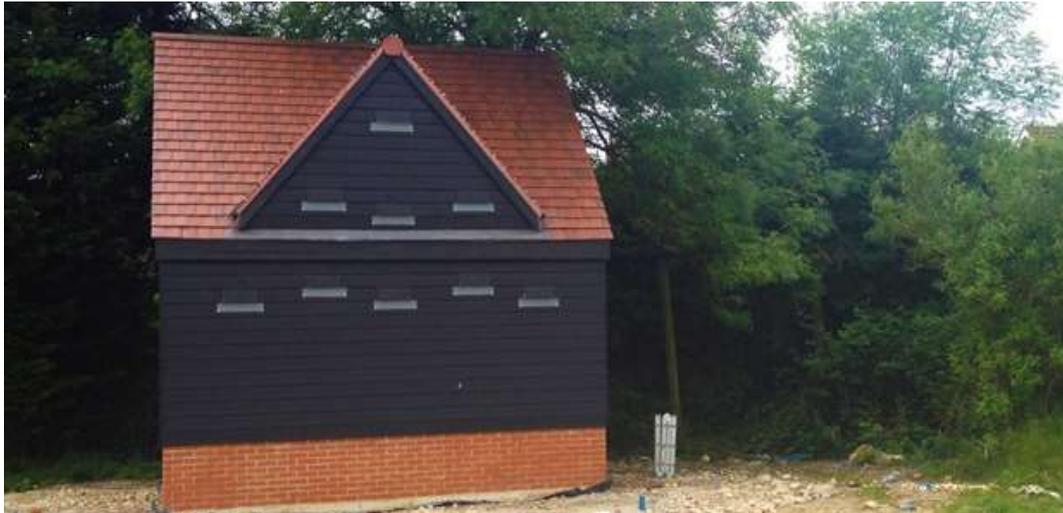
*Figure 11. New built roost for *Plecotus auritus* with slot entrances for crevice dwelling bats.*

A typical example of one of these structures is a new bat house at Brackley in the English midlands. The demolition of existing older buildings was undertaken to make way for a new housing development. The new bat house was constructed before the main development in order to allow the bats to become accustomed to the new roost. The new buildings was a square design and incorporated an open loft space as well as slot entrances and crevices for local *Pipistrellus* populations.

There were signs that bats were using the new roost within a matter of weeks of its construction.

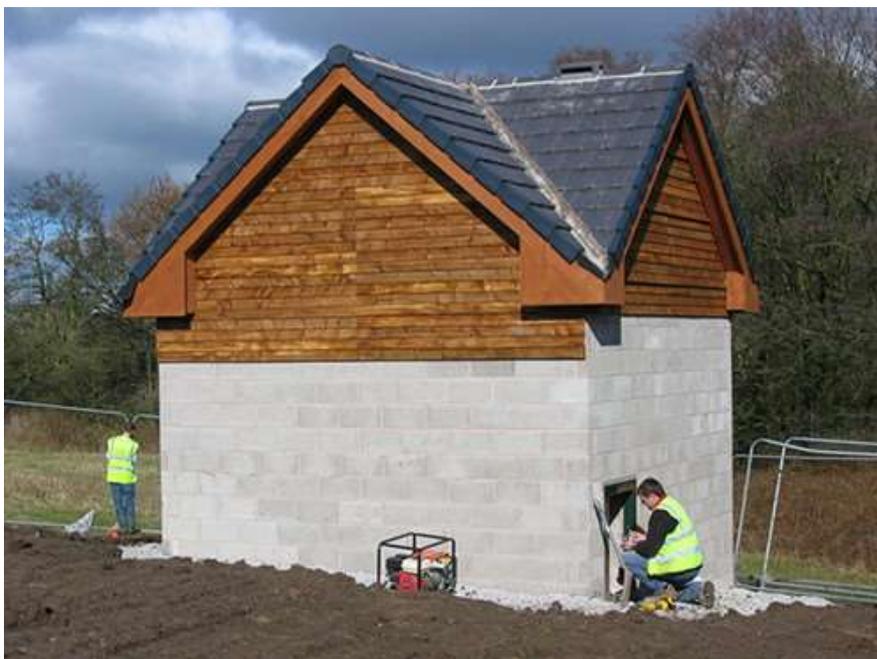
Figure 12. This roost was occupied by bats within five months of construction

A similar site was built in the north of England following the demolition of an ordnance factory. The roost followed a similar design to the Brackley bat house with block work walls and a tiled roof. Access points for the bats were via slot entrances in the gable walls and one of the ridge tiles.

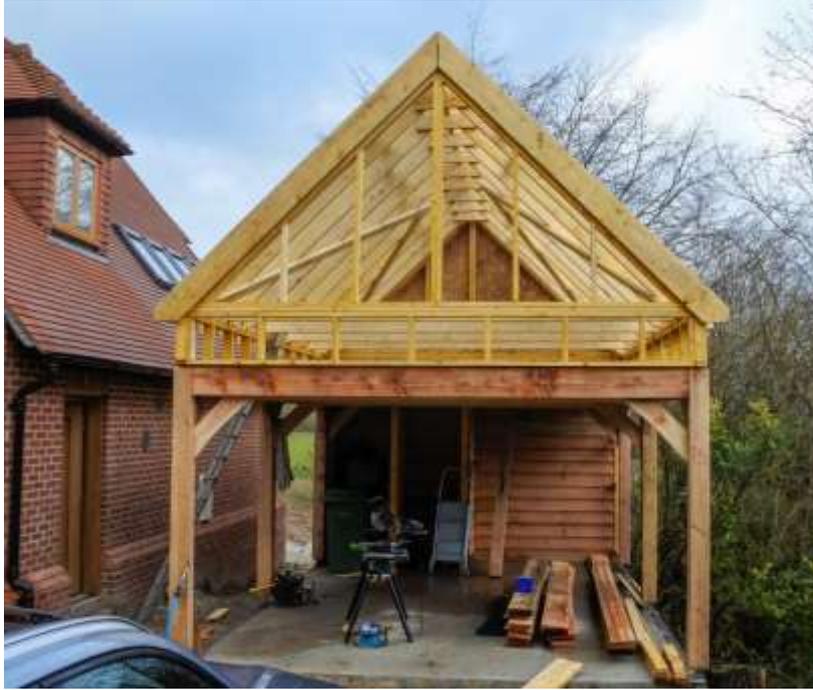
Figure 13. A dual use building with a garage below and bat roost above.

The funding of new build roosts is sometimes made more palatable for householders by incorporating areas of human use such as garaging for vehicles. This dual use building in southern England was also constructed for *P. auritus* bats. Figure 12 shows the open roof space under construction.

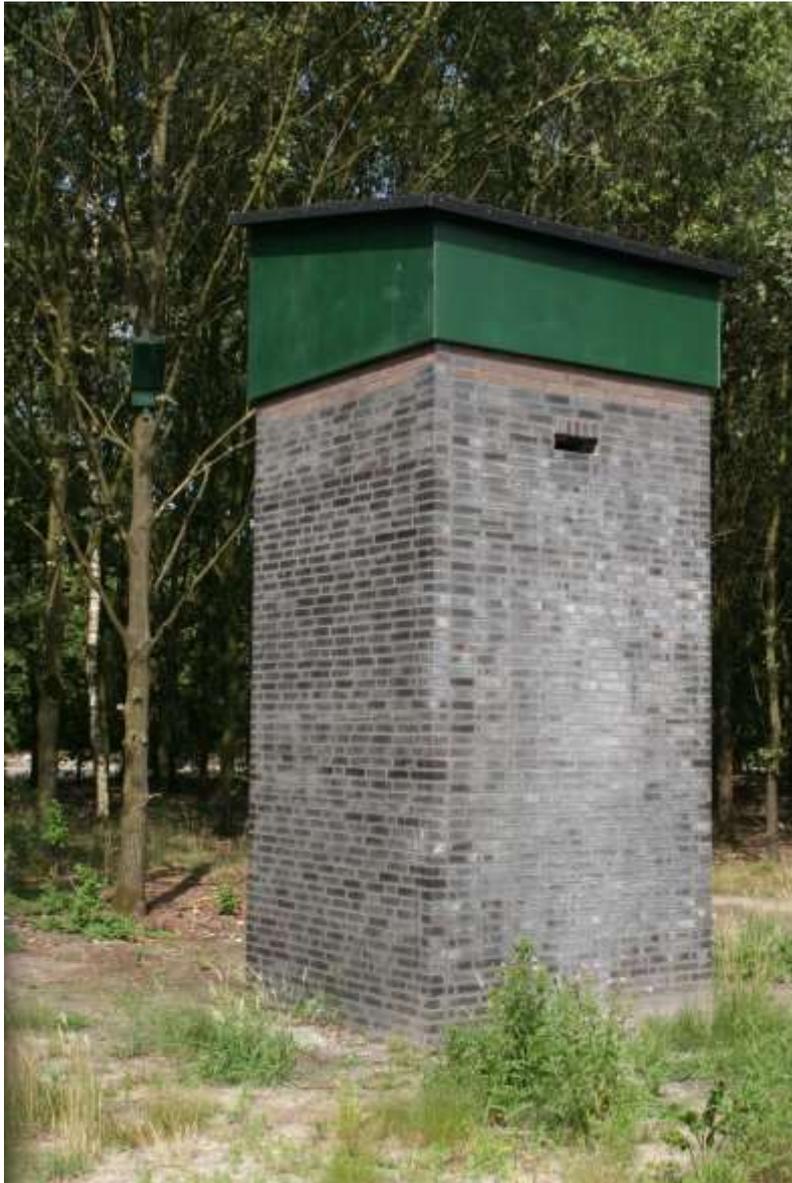
Figure 14. Dutch bat tower.

Conservation projects in the Netherlands led by the Dutch Mammal Society have constructed bat towers. Whereas the UK buildings previously described have been designed to provide new roosting opportunities for bats but have not attempted to mimic the roosts lost during a development, the Dutch designs aim to reproduce a whole suite of features found in the original roosts. The great advantage of these designs is the height. At 4m metres these bat houses maintain the elevation of the original roosts and their entrances. By building them so they have an aspect similar to the original roost and close to vegetation they try to reproduce similar microclimatic conditions to the roosts that have been lost.

These buildings are designed to be used by a range of species but particularly *Plecotus*, *Myotis* and *Pipistrellus* species.

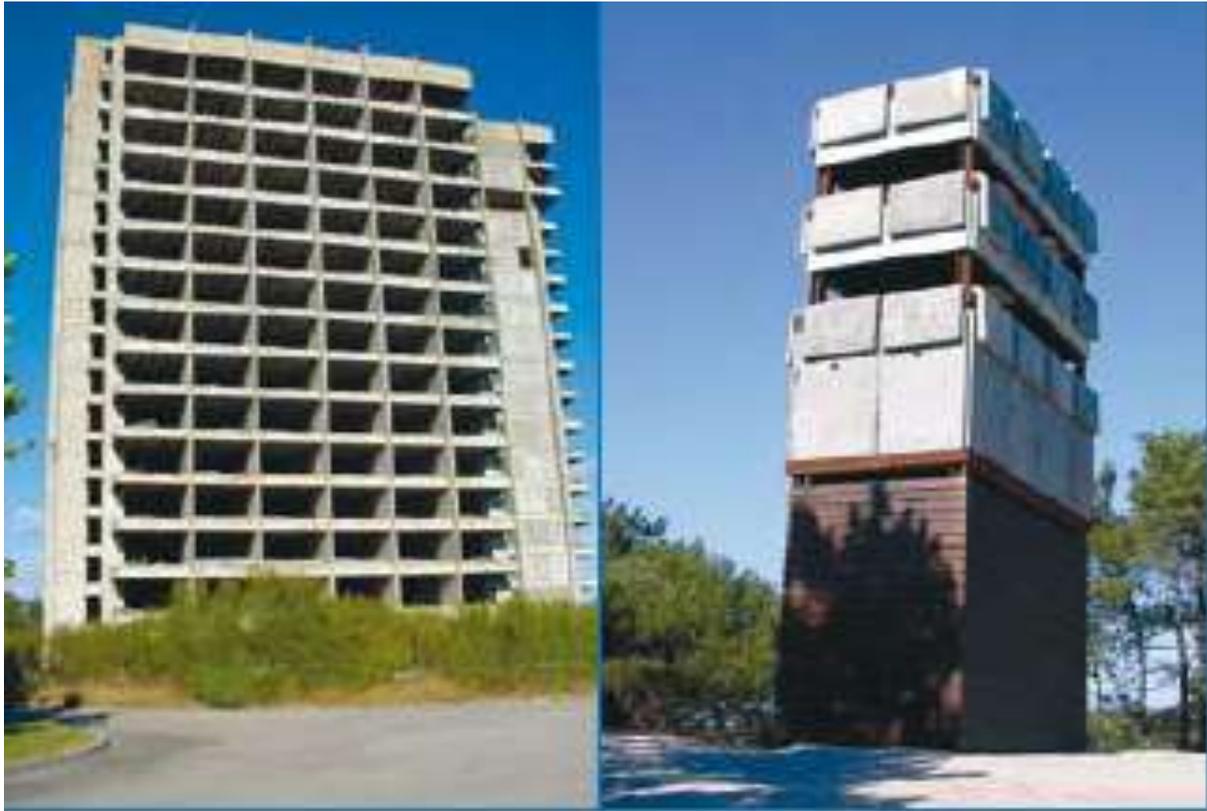
Figure 15. The original building at Mordegário Portugal (left) and the new purpose-built roost (right)

Concerted attempts to replicate roosting conditions have also been attempted in Portugal, where the destruction of a 15-storey building used by a colony of some 100 *Tadarida teniotis* and smaller numbers of *Eptesicus serotinus* and *Pipistrellus pygmaeus*, was compensated for with a purpose-built roost. The bats were found roosting in crevices behind the concrete skin of the building and to replicate this, the new building was constructed using the concrete plates from the original structure.

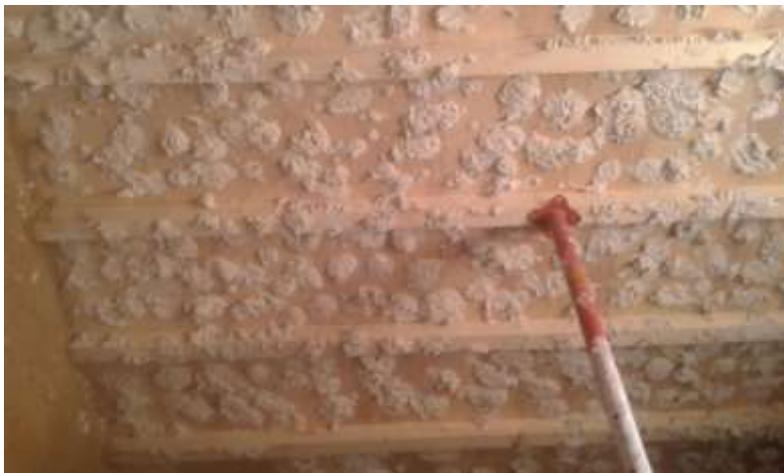
Figure 17. The rough surface on the ceilings provide the bats with perching sites

This project worked from scratch to recreate the buildings by manufacturing mud bricks in the traditional way and baking them in the sun. Roosting opportunities have been provided for the bats by creating holes and crevices inside the buildings.

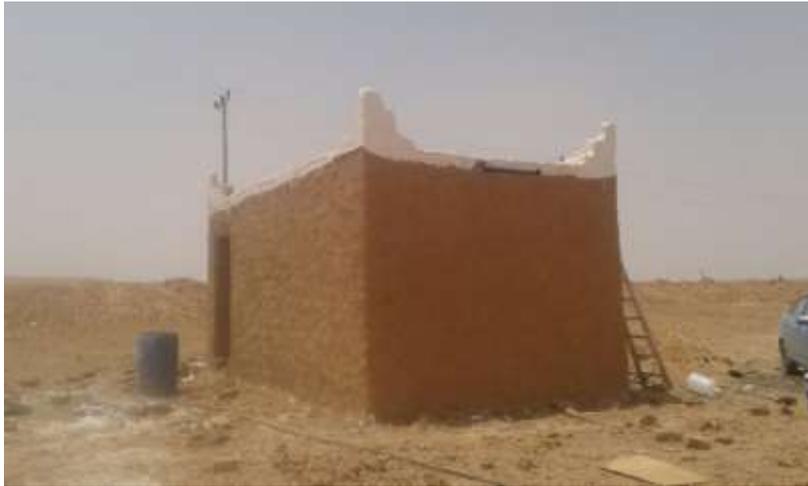
Figure 18. Newly constructed mud brick bat house.

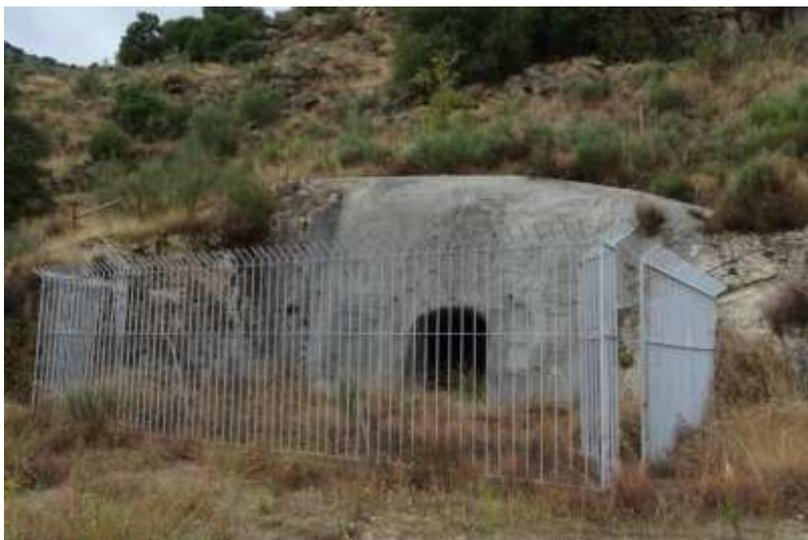
Figure 19. Fence entrance to new underground roost

A large number of species were affected by these developments including *R. ferrumequinum*, *R. hipposideros*, *R. mehelyi*, *R. mehelyi/euryle*, *M. myotis*, *M. daubentonii* and *Miniopterus schreibersii*. The developers were obliged to provide three replacement galleries to serve as alternative roosts. Surveys were conducted to determine the patterns of use of the original roosts along with data on temperature and humidity. The replacement roosts were located as close as possible to the originals and were fenced in order to reduce disturbance (Fig. 17).

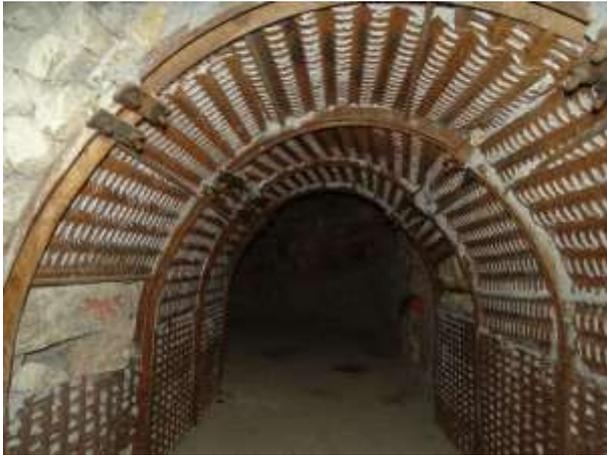
Figure 20. Excavated tunnel in the replacement roost

Tunnels were excavated in the rock which led to galleries of different heights. These height differences provided a range of different microclimates for the bats.

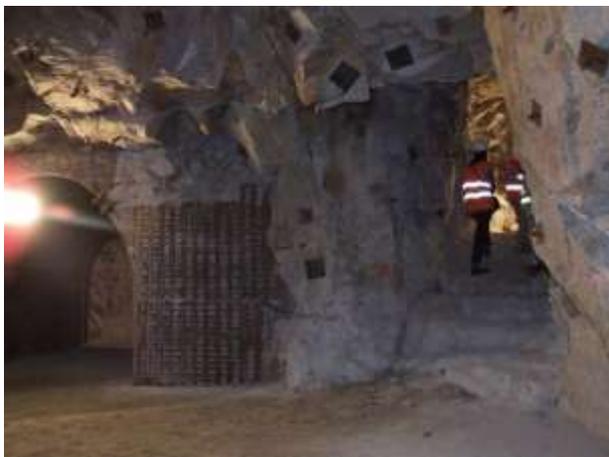
Figure 21. Galleries for the bats to roost in

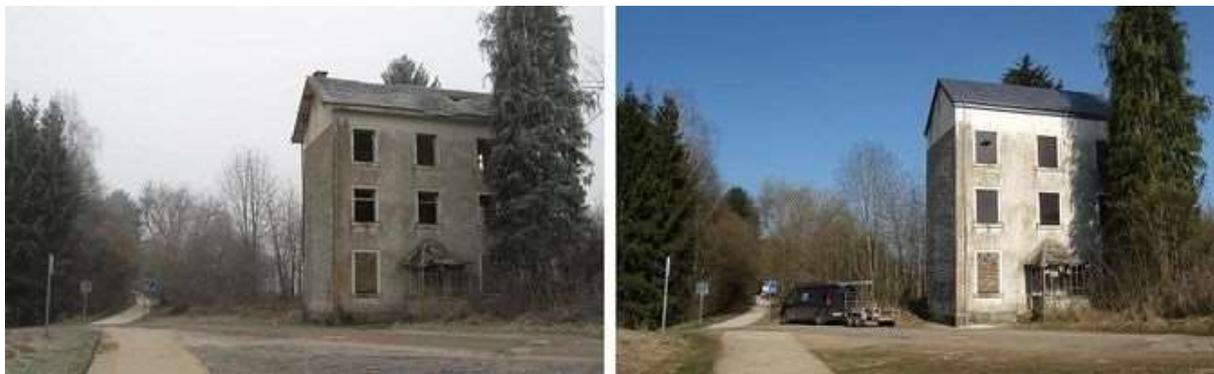
Figure 22. Before and after photographs of the old guard house in Viton

The privately owned building in Figure 20 was acquired on the 30 year lease by the local authority in Wallonia, Belgium. The project to adapt this disused house for bats intended to solve a number of conservation issues in the area. A roost of *Myotis myotis* locally was under threat by repeated disturbance and predation of the colony by *Martes foina*. In addition, there was a need to increase and improve roosting opportunities for local populations of *R. hipposideros*.

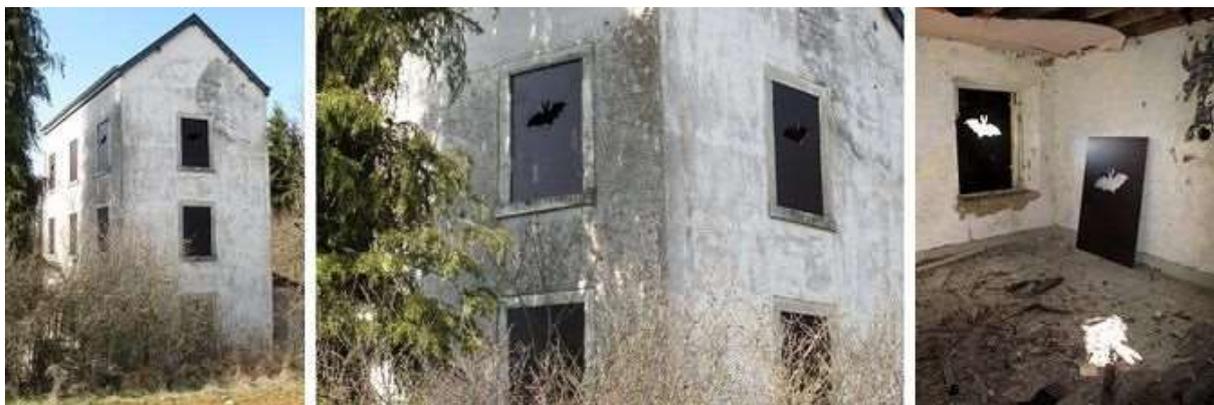
Figure 23. Photographs of the shutters and bat access holes

The building was re-roofed and shutters were placed over the open windows to make the interior darker for the bats. It was secured by metal doors on the ground floor to prevent unwanted access. Bat shaped entrance holes were cut into some of the shutters to provide access for the bats.

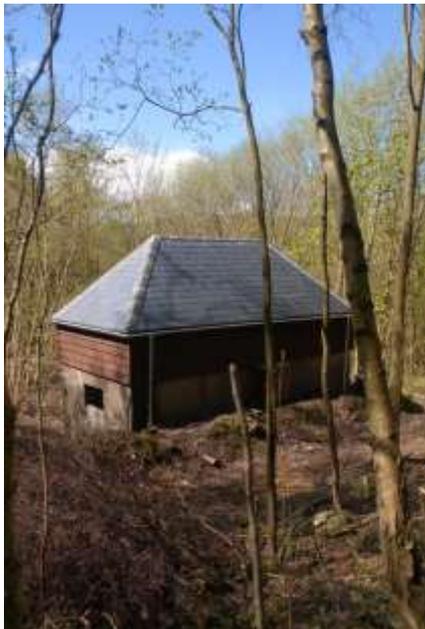
Figure 25. The completed conversion to a bat house

The roof of the wages office was lifted to provide a large void for the bats. As it was surrounded by trees and partially shaded, the ends of the roof were hipped to increase the solar gain to the building. The ground floor windows were blocked up and a new grilled entrance was added. Within three months *R. hipposideros* droppings were found inside the site and over the following two years day roosting bats were found in residence. After ten years the building is now occupied by a maternity colony of over 100 animals.

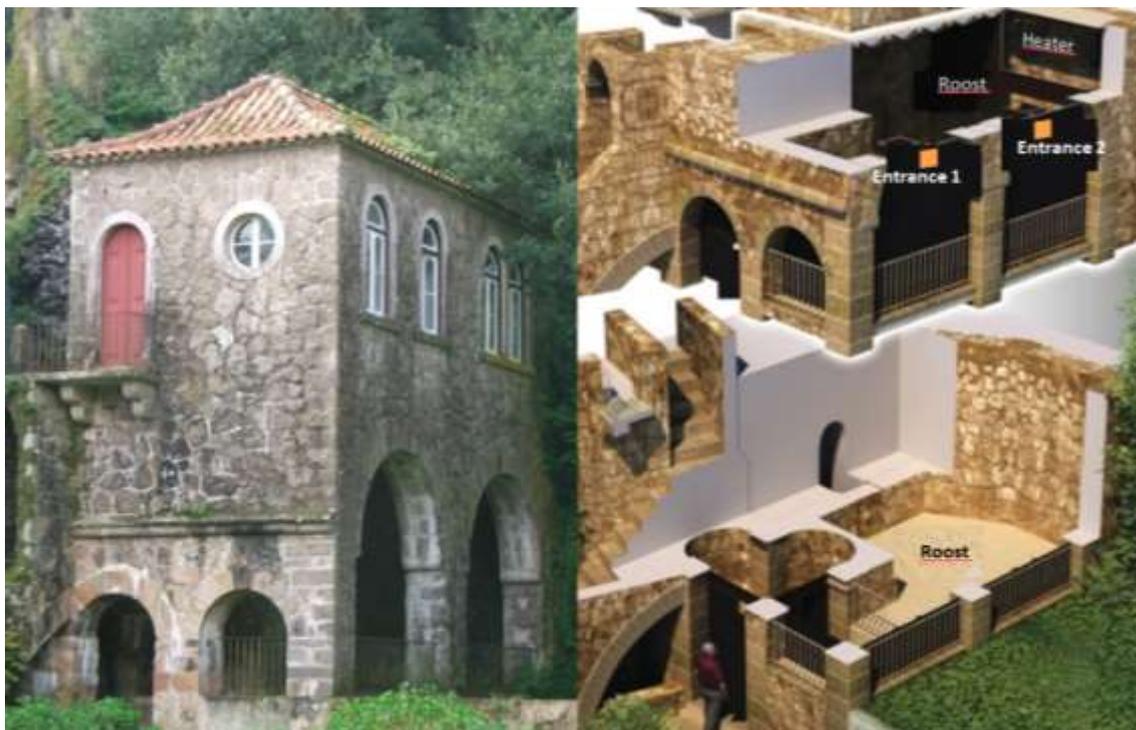
Figure 26. A photograph of the new roost building, along with a cutaway graphic showing the location of the roost, the entrances, and the location of the heaters.

Morcegário da Regaleira, a building located 30m from the temporary roost was chosen. The room was approximately 7m long, 3 wide and 5 m high. Following modifications to the building guano was placed in the roost and a small number of bats were translocated there. Over the following two years only individual bats were recorded using the new roost. Following the installation of a heater into the space the colony finally moved and started to breed in the site, allowing the temporary roost to be closed to the bats. In addition to the maternity use of the site by c200 bats, smaller numbers of *R. hipposideroscan* be found in the building throughout the year. The site is also now used by small numbers of *R. ferrumequinum*, *R. euryale* and *Plecotus sp.*

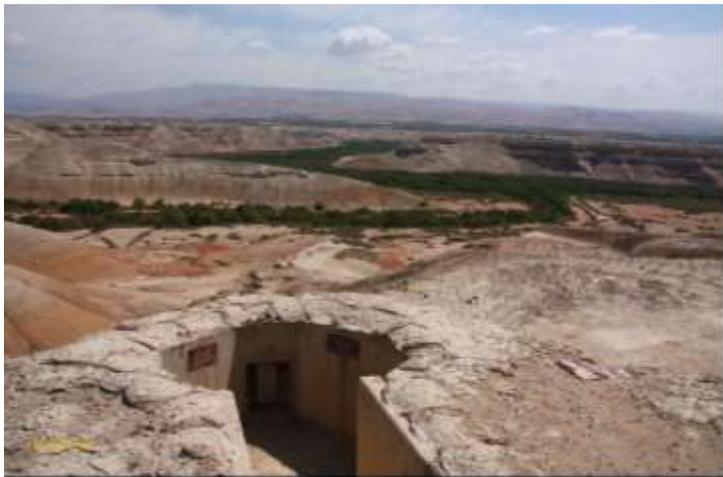
Figure 27. Entrance into the modified bunkers

Following the 1994 peace treaty between Israel and Jordan, Israeli military bunkers were abandoned, and it was observed that numbers of bats had started to occupy the sites, including *Asellia tridens*, *Rhinopoma hardwickii* and *Rhinolophus clivosus*. Although the underground bunkers provided a suitable microclimate for the bats, their use as roosts was restricted by the smooth concrete ceilings of the bunkers resulting in a lack of suitable surfaces for the bats to hang from. The project addressed this issue by roughing up the smooth ceilings of the bunkers by using polyurethane foam and cement. Plastic netting and wires were also attached to these surfaces.

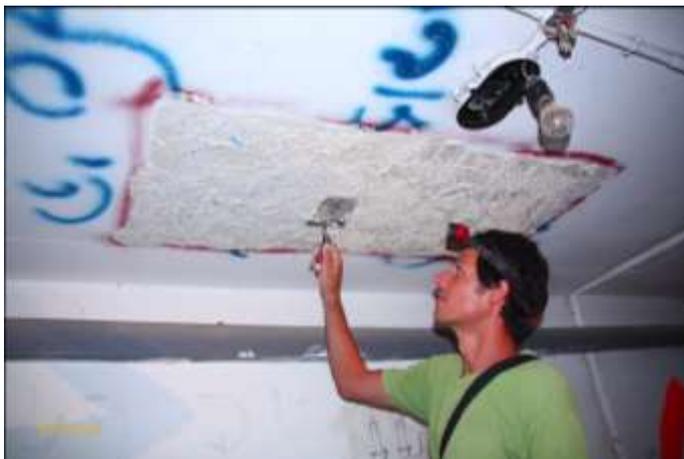
Figure 28. Roughing up the smooth ceilings

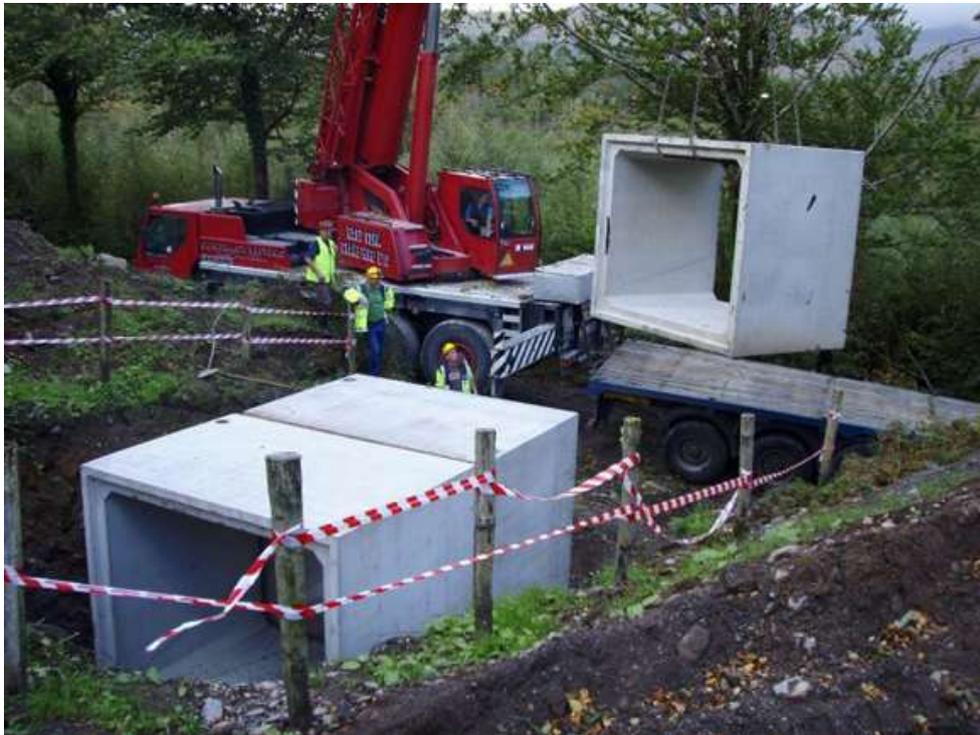
Figure 30. Square profile pre-cast concrete sections being loaded into place.

Flahive's hibernaculum in the west of Ireland was constructed to improve the resilience of a maternity colony of *R. hipposideros* that roosted in a building close-by. An earthen chamber had been dug into the site some eight years previously and although this had been used by small numbers of bats, it was starting to collapse and a new more robust hibernacula was needed. The front and back walls of the new structure were built using blockwork and the main chamber was formed by pre-cast concrete tubes. A block work baffle reduced air movement and reduced the light entering the chamber.

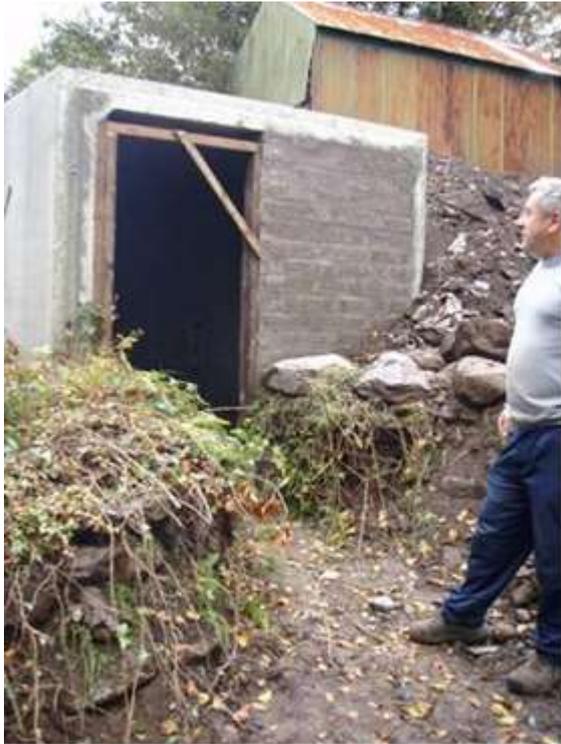
Figure 31. The new hibernation site before it was covered in earth

The structure had a door with a window to allow the bats access and was covered with earth and vegetation to provide insulation. The new hibernation site was a great success and in the five years following its construction the number of *R. hipposideros* using the site increased to two hundred.

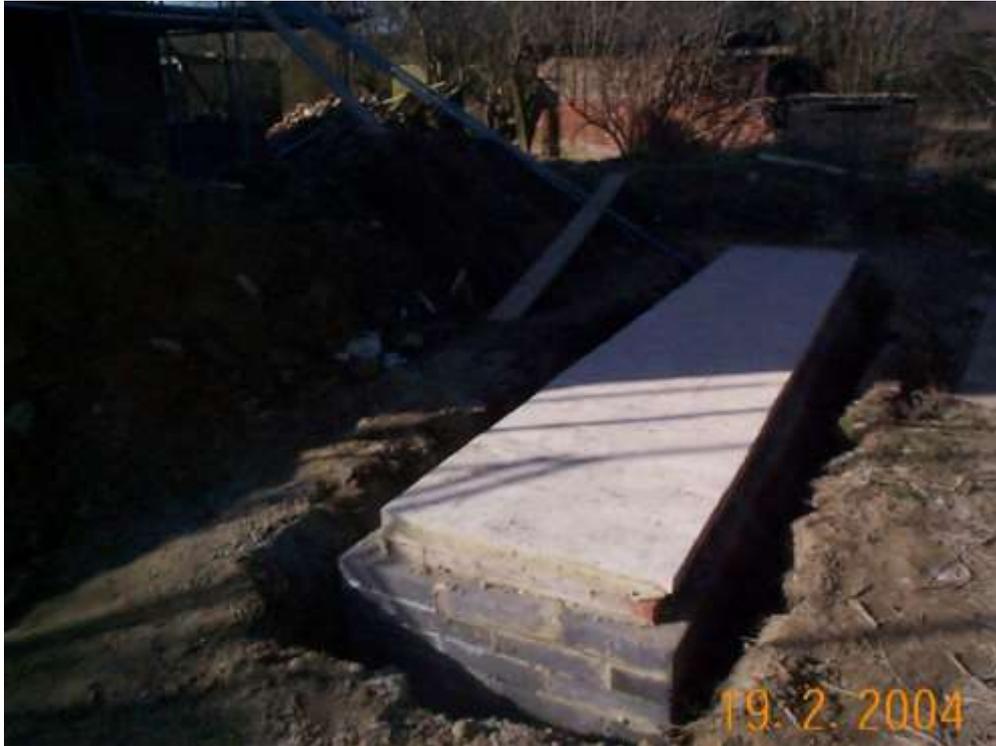
Figure 33. Part of the blockwork tunnel system connected to the maternity roost before it was covered over with earth

Directly linking purpose-built hibernation sites for Rhinolophids to their summer roosts can be very effective and provides the colony with all year around roosting opportunities. At a site in south-west England a simple tunnel was built using a cast concrete floor and ceiling with blockwork walls. The entrance to the L-shaped tunnel was located in a ground floor room of a disused building that was home to 150 *R. hipposideros*.

The tunnel ended in a small chamber where most of the bats hibernate. A small chimney at the end of one of the tunnels maintains some air-flow through the system and holes in the blockwork walls allow some water movement and keep the humidity levels high.

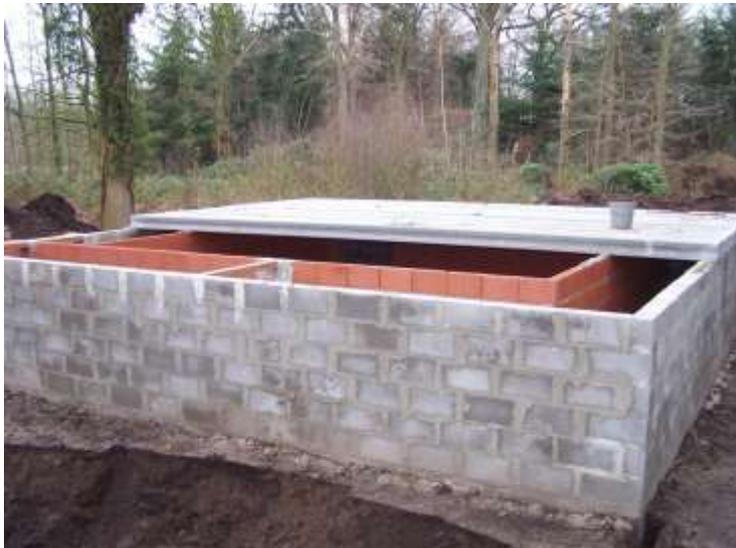
Figure 35. Showing the solid concrete walls and the lighter internal one.

The outside walls of the structure are made of concrete blocks, the inner walls of light-weight building blocks.

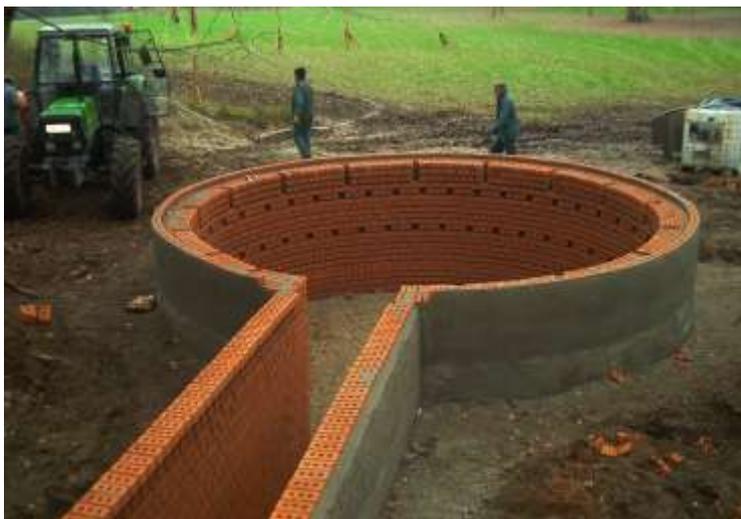
Figure 37. The Bulskampveld hibernation site part way through construction

Numerous gaps and crevices were provided for hibernating bats in the wall of the structure. The contractors built a dome of straw and sand on top of the chamber and used this as a forma for

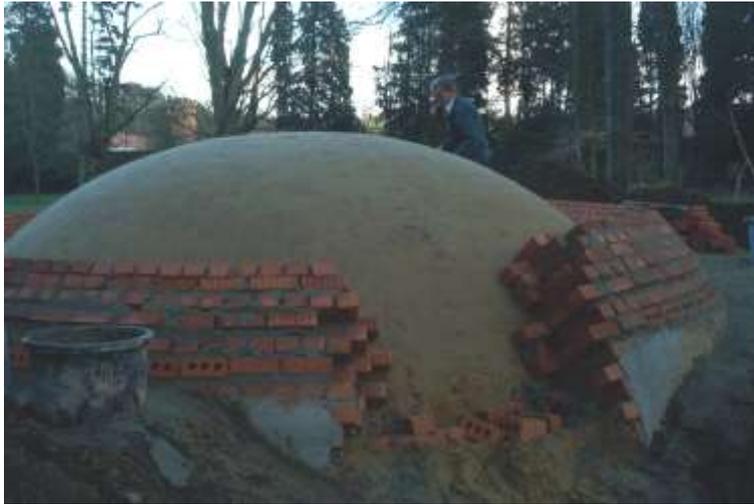
Figure 38. The brick dome being built over the straw and sand forma.

building a brick dome on the chamber.

When the dome was complete the straw and sand was removed from the inside of the chamber. The structure was then covered with earth and planted up.
