EUROBATS

Publication Series
No.

4

Protection of overground roosts for bats

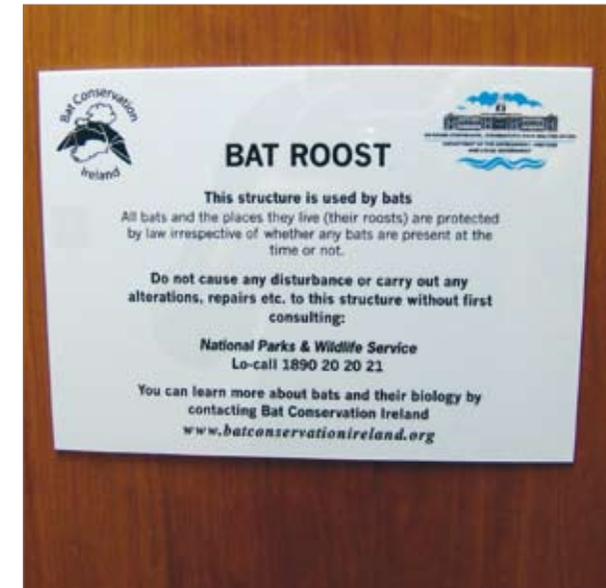
Figure 11. Example of bat roost notice in situ, Dublin, Ireland.
© F. Marnell

Although conservationists in general often prefer to keep the location of important, unprotected sites secret, sensible use of site notices can be an effective way of alerting developers to the importance of a building or bridge for bats. The notice might usefully state the legal provisions under which bats are protected and provide contact details for the relevant statutory nature conservation authority or NGO as appropriate. If the site is only important for bats for part of the year, the notice could explain this as well.

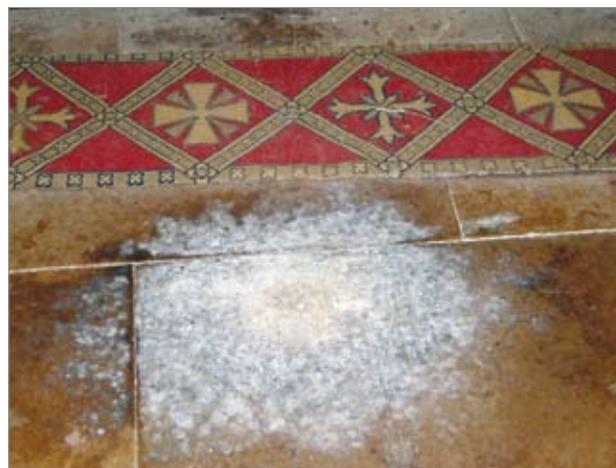
Figure 13. Damage to stonework at Penmon Priory, Wales, United Kingdom, due to long-term exposure to bat urine.

Droppings, over a protracted period of time, may cause pitting, long-term staining and etching to porous materials such as painted wall surfaces, wooden monuments and stone sculptures. Bat urine (which is 70% urea) is chemically more aggressive and therefore of even greater conservation concern. It can cause spotting and etching of wooden, metal and painted surfaces (PAINE 1993 & undated).

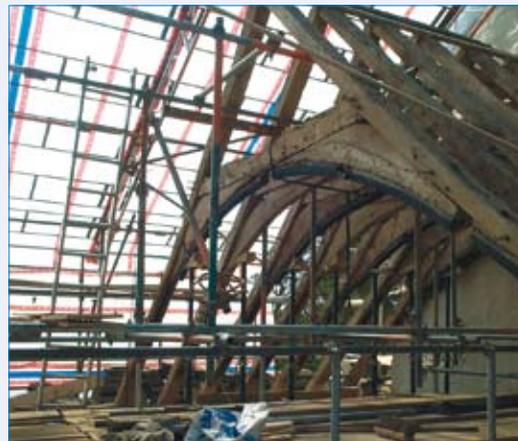
Figure 15. St Cadoc's Church, Wales, United Kingdom, undergoing essential repairs.
© C. Roberts

Three species of bat roost in St Cadoc's church in Wales – *Rhinolophus hipposideros*, *Plecotus auritus* and *Myotis nattereri*. The church dates back to the early 1200s and is of considerable historical importance. In 2002 it was discovered that essential repairs were required and scaffolding was immediately erected to stop the roof from collapsing. No further works were carried out, however, until the bats had left the church in the autumn. At that stage a polythene tent was constructed over the roof to allow the restoration works to be carried out over the winter months with a view to having the building ready for occupation by bats again the following spring.

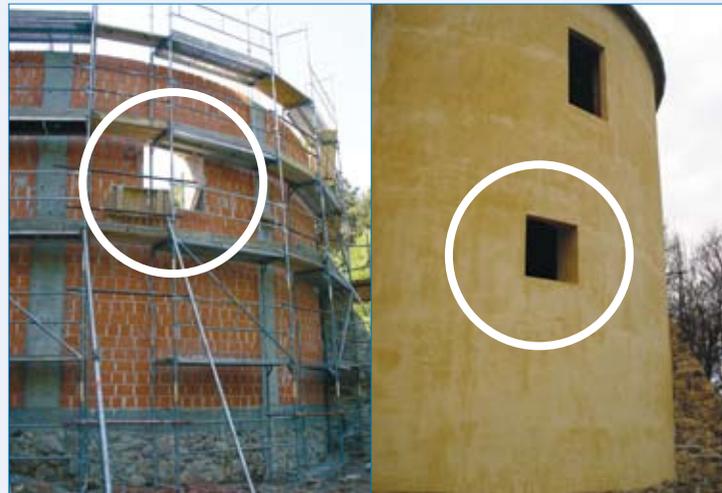
Figure 16. Northwest tower of Grad na Goričkem castle, Slovenia, during and at the end of reconstruction in year 2006 (circles mark new entrance openings for bats).

The building works required the complete demolition and reconstruction of parts of the castle used by bats. On the basis of the research, mitigation measures were recommended during the renovation, includ-

ing the designation of part of the cellars as a bat roost. Extensive discussion took place between nature conservation and cultural heritage officers to agree the position and size of a new entrance for bats (Figure 16). Follow up monitoring is now required to ensure that the conservation measures are effective, but it seems that the conservation efforts to date have been successful.

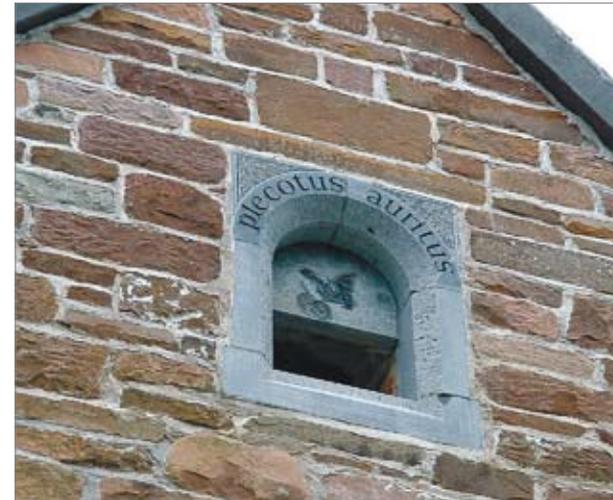
Figure 17. Dedicated bat roost entrance, Ireland (also used by lesser horseshoes!). © C. Kelleher

Rhinolophus species and *Miniopterus schreibersii* generally prefer entrances they can fly through (see MITCHELL-JONES & McLEISH (2004), chapter 11 for details and designs), but other species will generally use smaller holes or slits to crawl through. Wherever possible, it is preferable to maintain entrances in their original position so the bats will have no difficulty finding them. Retention of vegetation close to roost entrances can also be important. This provides continuity of flight routes and cover for the bats which protects them from avian predators. External lighting, such as security lights or road or path lighting, close to roost entrances should be avoided (see DOWNS *et al.* 2003, REITER & ZAHN 2006).

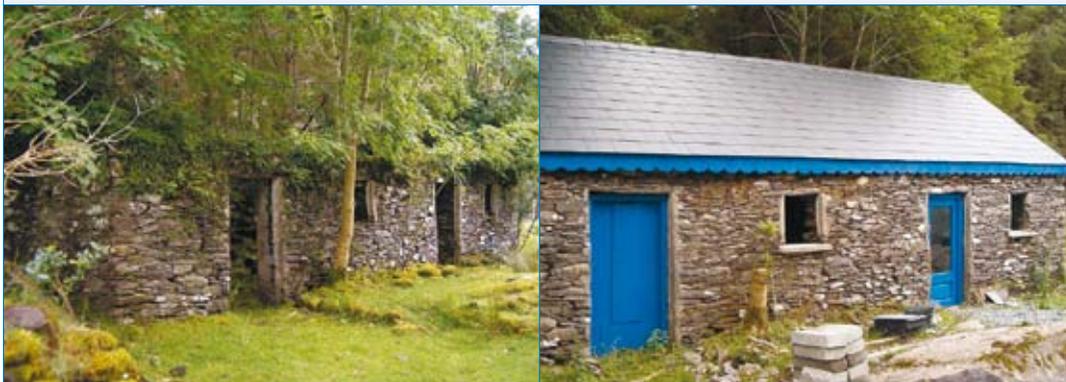
Figure 18. Outbuilding at Glaninchiquin, Ireland, before and after renovation for *Rhinolophus hipposideros*.

The original roost had a count of 150+ bats in 2003. 130 bats remained in the old roost despite considerable disturbance during 2004. The new roost was constructed at the end of 2004 and by May 2005, the bats had moved in. The peak count for the new roost in 2005 was c. 120. Bats were not able to enter the original roost by this time as all access points had been sealed. The peak count in the new roost in 2007 had risen to 150 animals.

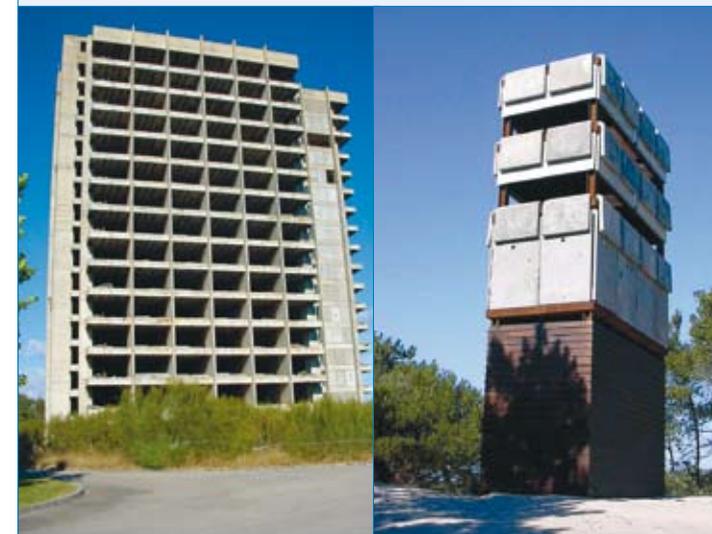
Figure 19. Old and new *Tadarida* roosts, Portugal.

a) Original building.

and 4 *Pipistrellus pygmaeus* were recorded in the new roost. In 2007, the maximum numbers seen were 11 *Tadarida teniotis*, 11 *Eptesicus serotinus* and 7 *Pipistrellus pygmaeus*. Monitoring of the new roost is continuing.

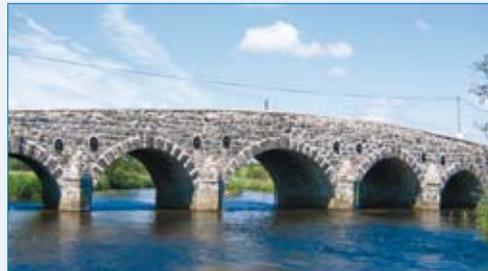
Figure 21. Lisconny Bridge, Ireland, after restoration.
© C. Shiel

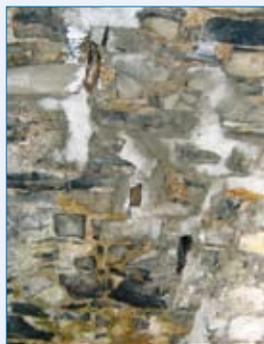
Figure 22. Underside of Lisconny Bridge; showing the three sections of the deep fissure that were left open to accommodate the nursery colony of *Myotis daubentonii*. The nursery roost is located in the lowest section. Note how the stonework was carefully grouted around and not over.
© C. Shiel
