A Review of Purpose-built Roosts for European Bats

H Schofield, A. Alagaili, M.-J Dubourg Savage, T. Kervyn, F Marnell, L. Rodrigues,

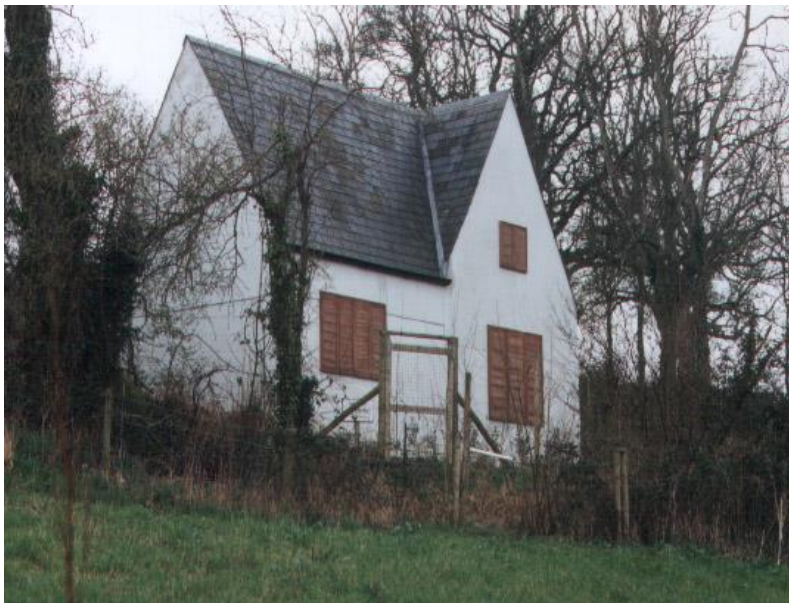
Figure 1. Bellaire Bat House. The false shutters were added to this building after construction to make it look less conspicuous.

The first of these bat houses to be built in Britain was in 1998, a new road development in southern England ran close to a small, deserted cottage, which was found to contain a colony of less than 20 *Rhinolophus hipposideros*. The roofing slates had been partially removed and the building was in danger of collapsing and had to be demolished. The new roost was constructed some 100m away, similar in size to the original roost, the new building was constructed in an L-shape to improve the solar gain to the roof, which was steeply pitched to create a wide range of temperature gradients inside for the bats.

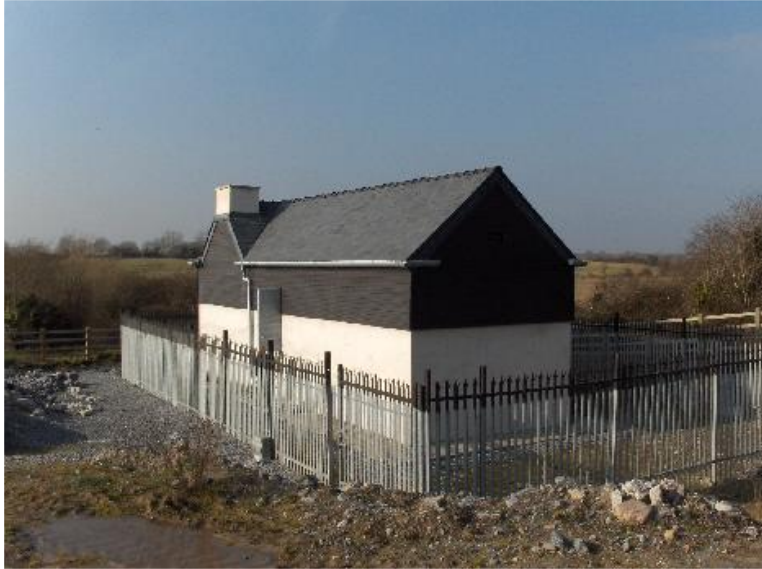
Figure 2. The Ennis bat house shortly after construction.

A more ambitious bat house for *R. hipposideros* was constructed near Ennis in the west of Ireland in 2005 as mitigation for a housing development. The building was 14m long and 8m high and made provision for a maternity roosting area in the roof as well as a hibernation area in the basement. It

was built some 400m from the original roost, which contained a small colony of only 5 bats. Take up of the building by the local population of *R. hipposideros* has been very limited. After seven years only two bats were recorded hibernating in the site, and one was observed in the roof void in the summer.

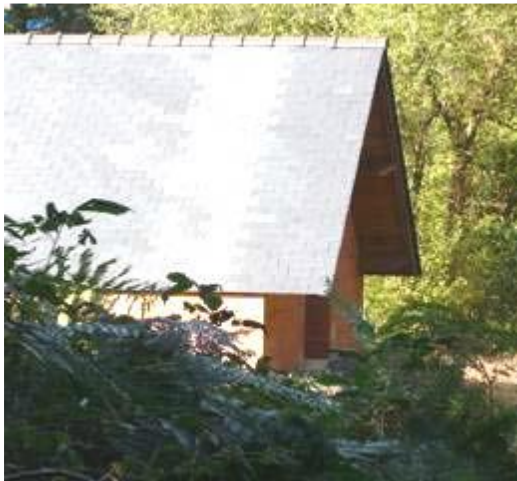
Figure 7. The Breton Mammal Group also cleared rubbish and planted vegetation around the site.

The site was adopted by hibernating bats within a few months, but it took five years before a maternity colony was using the building. The overwintering bats number some 120 individuals with a maternity colony of 100 bats.

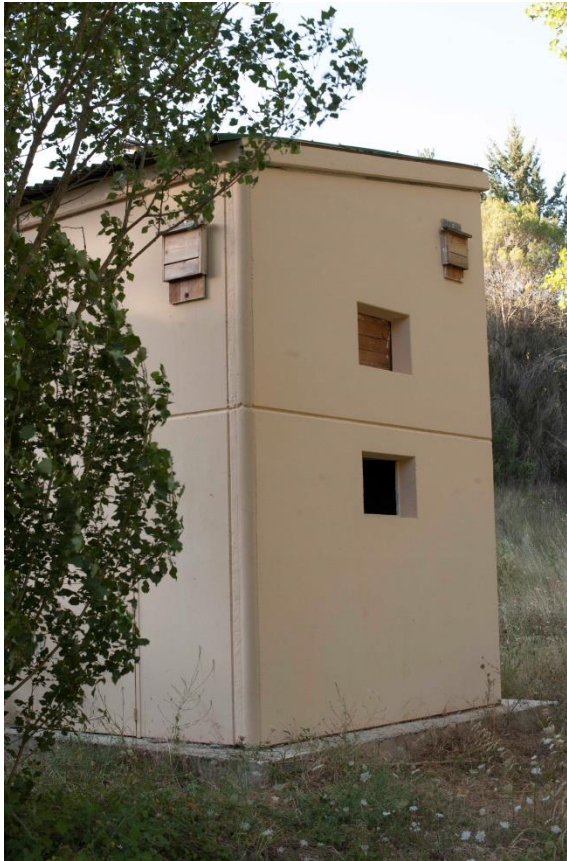
Figure 8. The larger *R. ferrumequinum* roost made out of two sections.

The new sites were constructed of pre-formed concrete sections manufactured off site. The larger of the structures was 2.6m square and 4m high, the smaller was 2m square and 3.2m high. Both had smooth exteriors and rough interiors, wooden boarding was attached to the ceiling in areas to provide extra purchase for the bats.

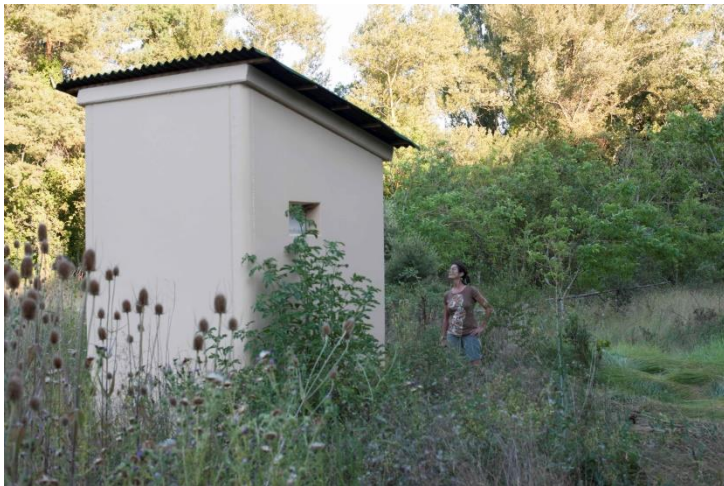
Figure 9. The smaller *R. hipposideros* roost.

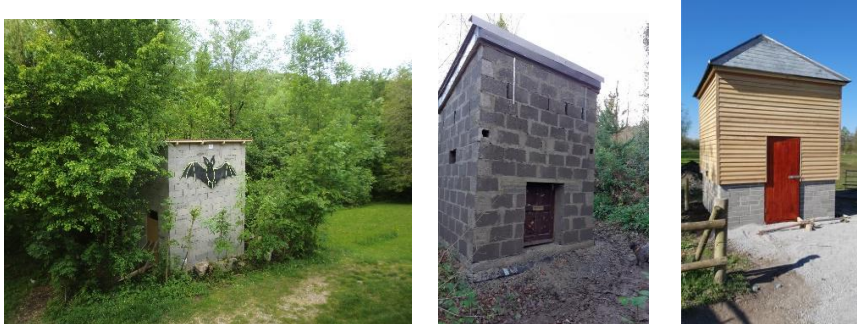
Figure 10 Bat towers constructed for *Rhinolophus hipposideros* in France (left), Ireland (centre) and the UK (right)

Following these successes in Spain, the idea of bat towers for Rhinolophids has been trialed successfully in France. These structures have also been built in Ireland and the UK, with the sites being adopted by *R. hipposideros* within months of being completed.

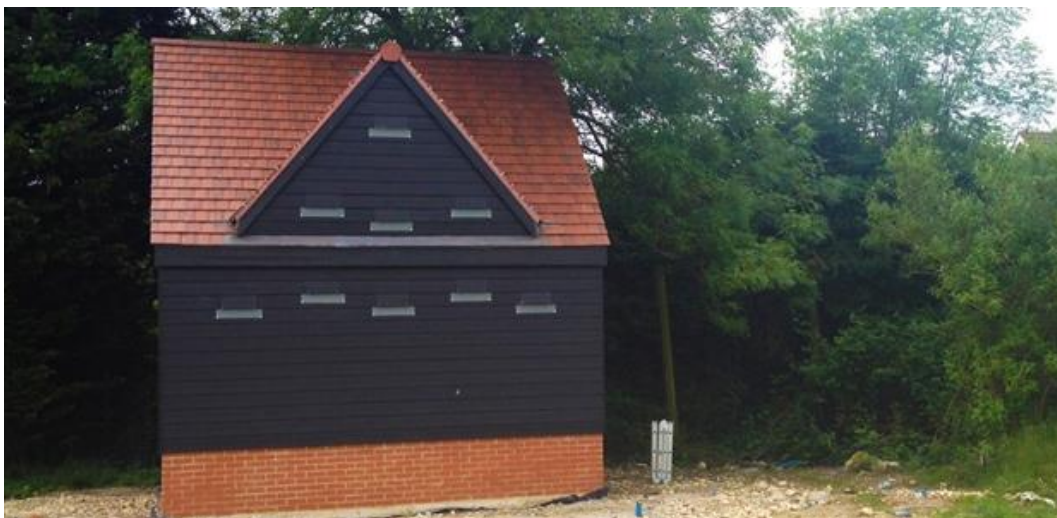
*Figure 11. New built roost for *Plecotus auritus* with slot entrances for crevice dwelling bats (@ecologybydesign).*

A typical example of one of these structures is a new bat house at Brackley in the English midlands. The demolition of existing older buildings was undertaken to make way for a new housing development. The new bat house was constructed before the main development in order to allow the bats to become accustomed to the new roost. The new building was a square design and incorporated an open loft space slot entrances and crevices for local *Pipistrellus* populations.

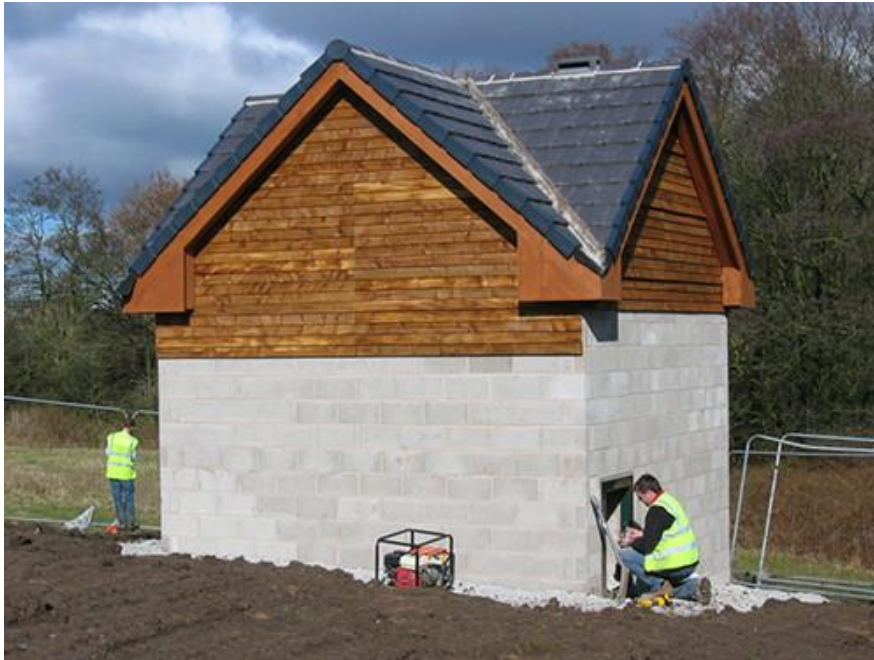
Figure 12. This roost was occupied by bats within five months of construction (@Bowland Ecology)

A similar site was built in the north of England following the demolition of an ordnance factory. The roost followed a similar design to the Brackley bat house with block work walls and a tiled roof. Access points for the bats were via slot entrances in the gable walls and one of the ridge tiles.

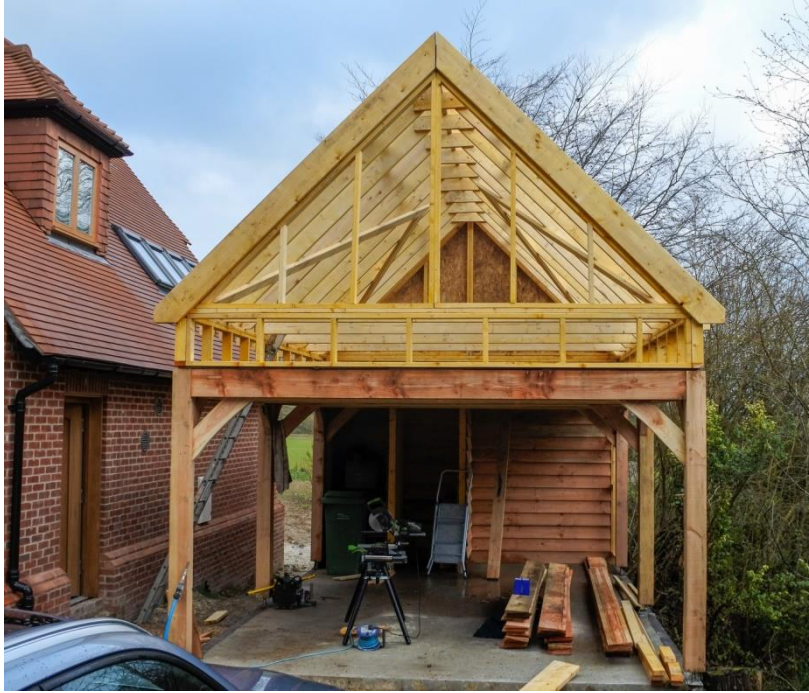
Figure 13. A dual use building with a garage below and bat roost above.

The funding of new build roosts is sometimes made more palatable for householders by incorporating areas of human use such as garaging for vehicles. This dual use building in southern England was also constructed for *P. auritus* bats. Figure 12 shows the open roof space under construction.

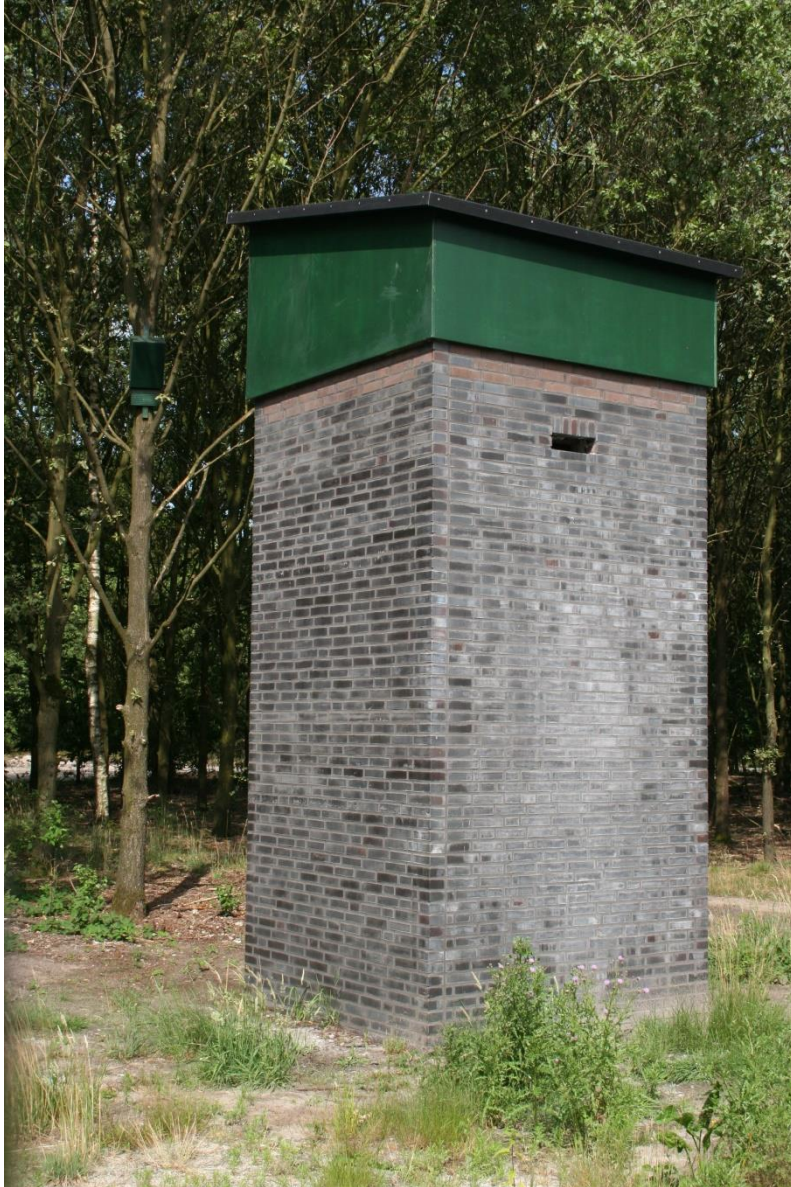
Figure 14. Dutch bat tower.

Conservation projects in the Netherlands led by the Dutch Mammal Society have constructed bat towers. Whereas the UK buildings previously described have been designed to provide new roosting opportunities for bats but have not attempted to mimic the roosts lost during a development, the Dutch designs aim to reproduce a whole suite of features found in the original roosts. The great advantage of these designs is the height. At 4 metres these bat houses maintain the elevation of the original roosts and their entrances. By building them so they have an aspect similar to the original roost and close to vegetation they try to reproduce similar microclimatic conditions to the roosts that have been lost.

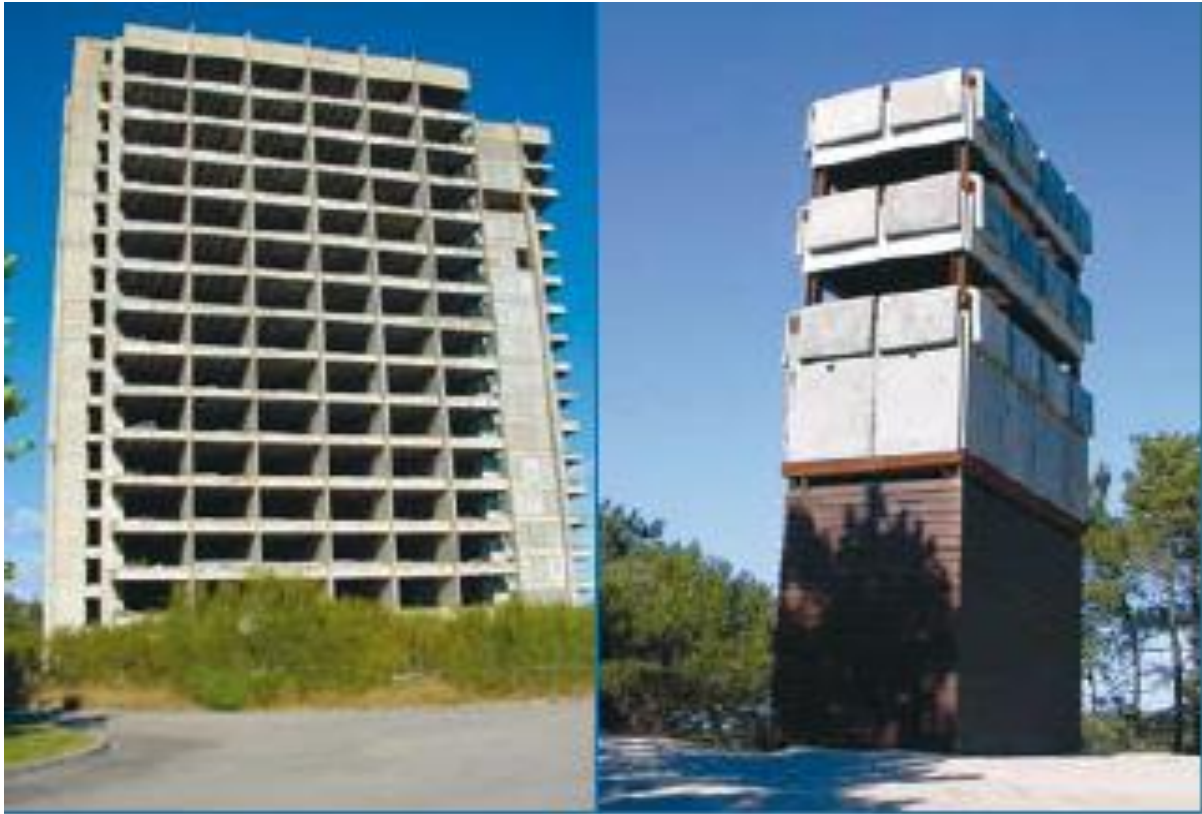
Figure 15. The original building at Mordegário Portugal (left) and the new purpose-built roost (right)

Concerted attempts to replicate roosting conditions have been attempted in Portugal, where the destruction of a 15-storey building used by a colony of some 100 *Tadarida teniotis* and smaller numbers of *Eptesicus serotinus* and *Pipistrellus pygmaeus*, was compensated for with a purpose-built roost. The bats were found roosting in crevices behind the concrete skin of the building and to replicate this, the new building was constructed using the concrete plates from the original structure.

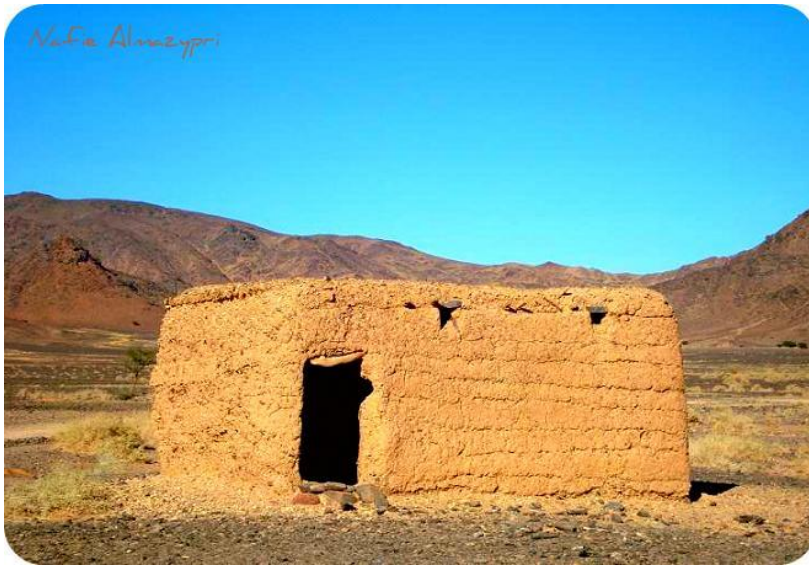
Figure 16. Traditional mud brick buildings in Saudi Arabia

This project worked from scratch to recreate the buildings by manufacturing mud bricks in the traditional way and baking them in the sun. Roosting opportunities have been provided for the bats by creating holes and crevices inside the buildings.

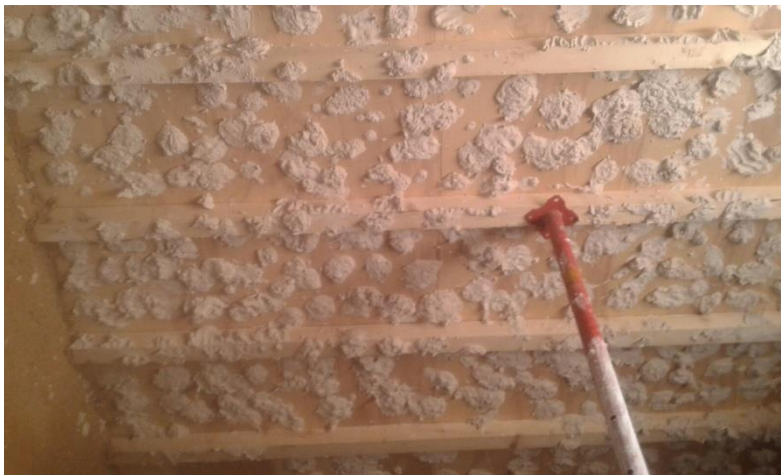
Figure 17. The rough surface on the ceilings provide bats with perching sites

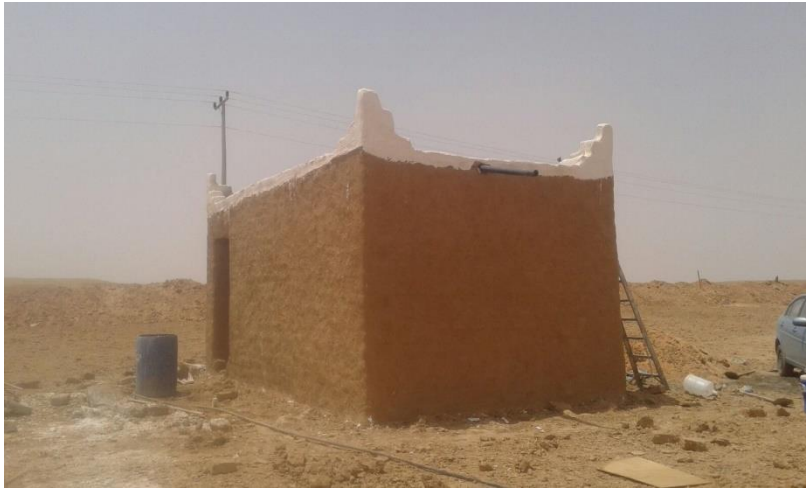
Figure 18. Newly constructed mud brick bat house.

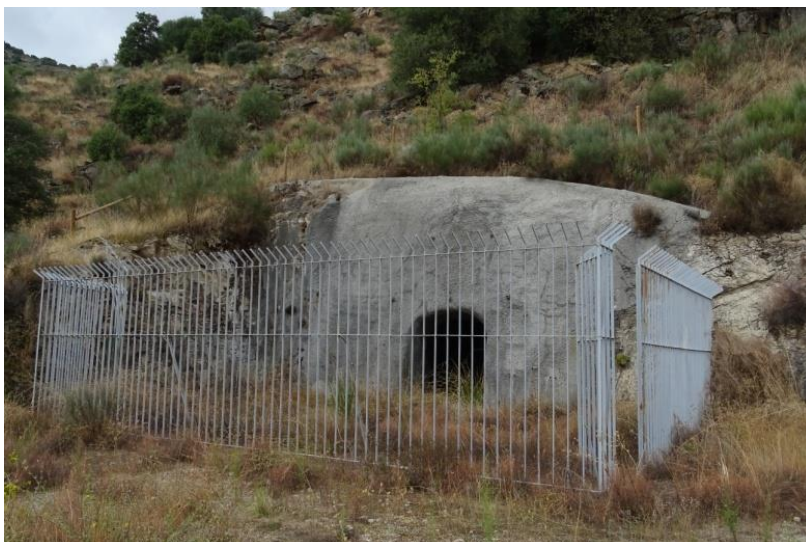
Figure 19. Fence entrance to new underground roost

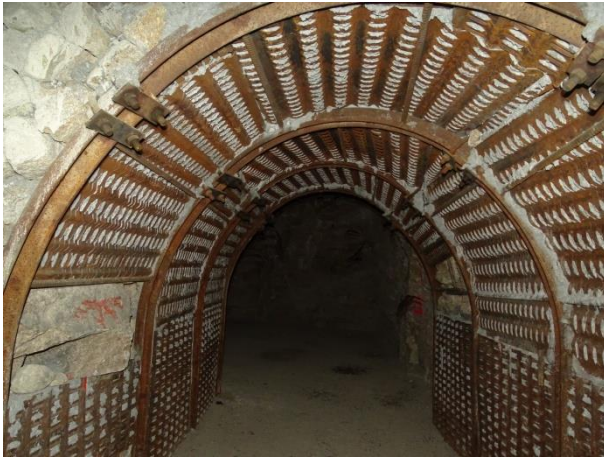
Figure 20. Excavated tunnel in the replacement roost

Tunnels were excavated in the rock which led to galleries of different heights. These height differences provided a range of different microclimates for the bats.

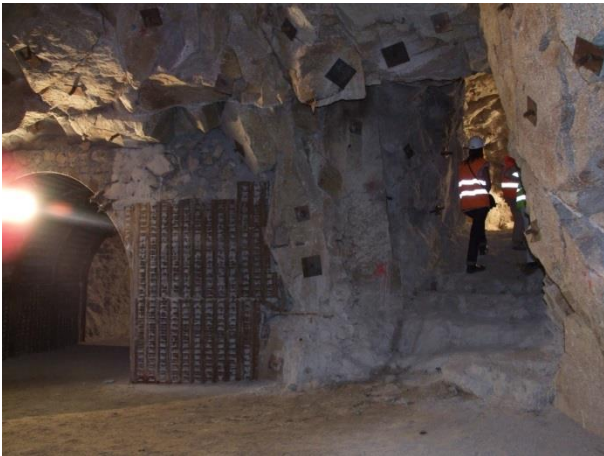
Figure 21. Galleries for the bats to roost in

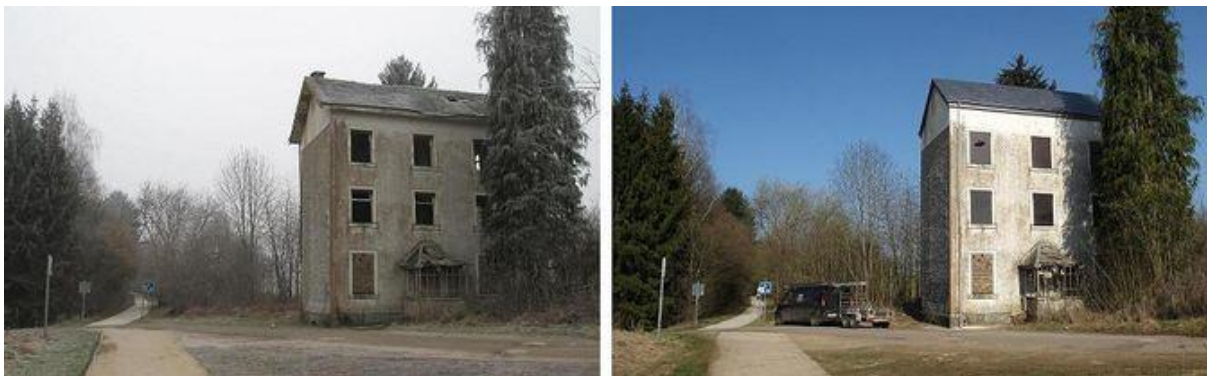
Figure 22. Before and after photographs of the old guard house in Virton

The building was re-roofed and shutters were placed over the open windows to make the interior darker for the bats. It was secured by metal doors on the ground floor to prevent unwanted access. Bat shaped entrance holes were cut into some of the shutters to provide access for the bats.

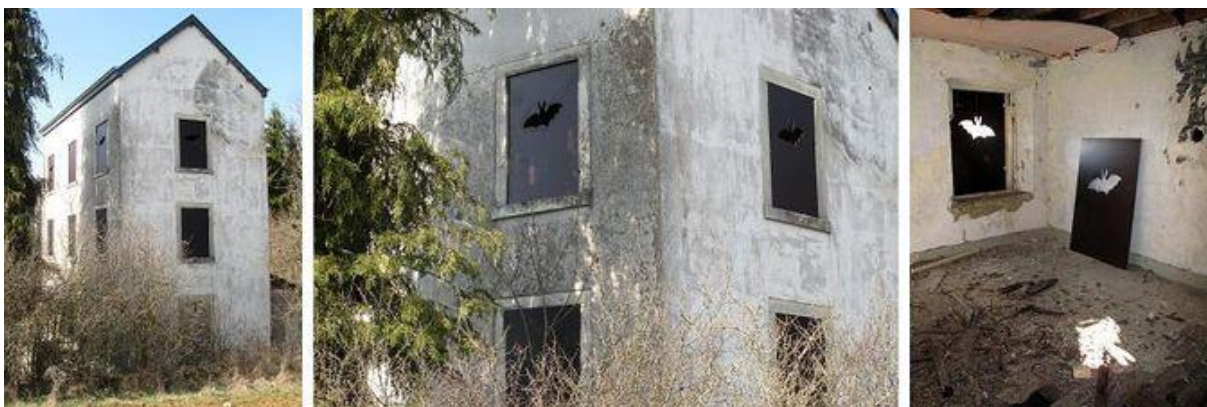
Figure 23. Photographs of the shutters and bat access holes

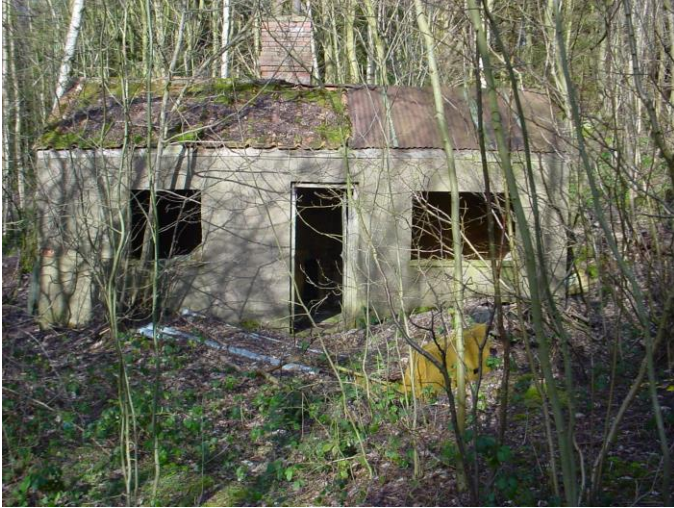
Figure 24. The derelict mine wages office

The roof of the wages office was lifted to provide a large void for the bats. As it was surrounded by trees and partially shaded, the ends of the roof were hipped to increase the solar gain to the building. The ground floor windows were blocked up and a new grilled entrance was added. Within three months *R. hipposideros* droppings were found inside the site and over the following two years day roosting bats were found in residence. After ten years the building is now occupied by a maternity colony of over 100 animals.

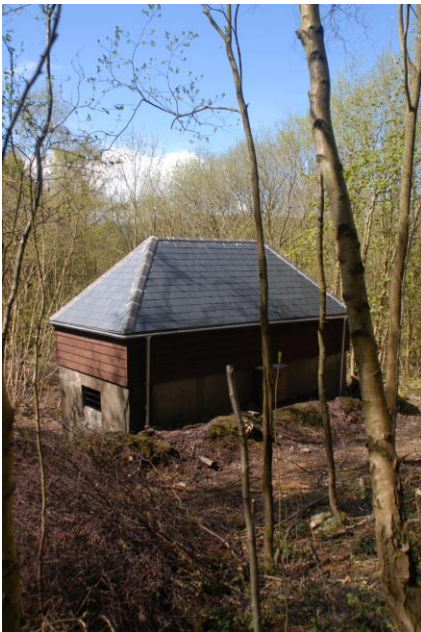
Figure 25. The completed conversion to a bat house

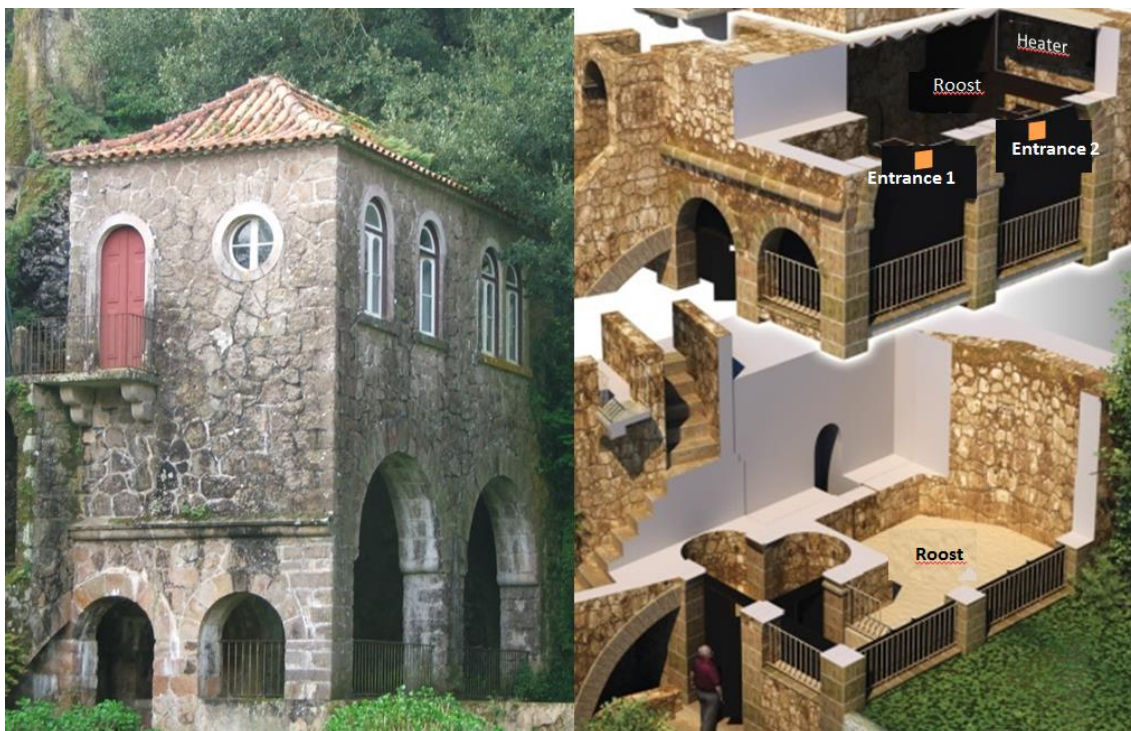
Figure 26. A photograph of the new roost building, along with a cutaway graphic showing the location of the roost, the entrances, and the location of the heaters.

Morcegário da Regaleira, a building located 30m from the temporary roost was chosen. The room was approximately 7m long, 3m wide and 5m high. Following modifications to the building guano was placed in the roost and a small number of bats were translocated there. Over the following two years only individual bats were recorded using the new roost. Following the installation of a heater into the space the colony finally moved and started to breed in the site, allowing the temporary roost to be closed to the bats. In addition to the maternity use of the site by c200 bats, smaller numbers of *R. hipposideros* can be found in the building throughout the year. The site is also now used by small numbers of *R. ferrumequinum*, *R. euryale* and *Plecotus* sp.

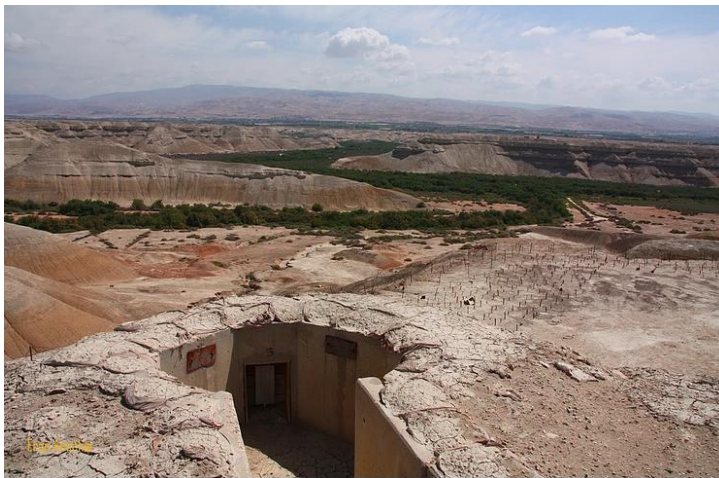
Figure 27. Entrance into the modified bunkers

Following the 1994 peace treaty between Israel and Jordan, Israeli military bunkers were abandoned, and it was observed that numbers of bats had started to occupy the sites, including *Asellia tridens*, *Rhinopoma hardwickii* and *R. clivosus*. Although the underground bunkers provided a suitable microclimate for the bats, their use as roosts was restricted by the smooth concrete ceilings of the bunkers resulting in a lack of suitable surfaces for the bats to hang from. The project addressed this issue by roughing up the smooth ceilings of the bunkers by using polyurethane foam and cement. Plastic netting and wires were also attached to these surfaces.

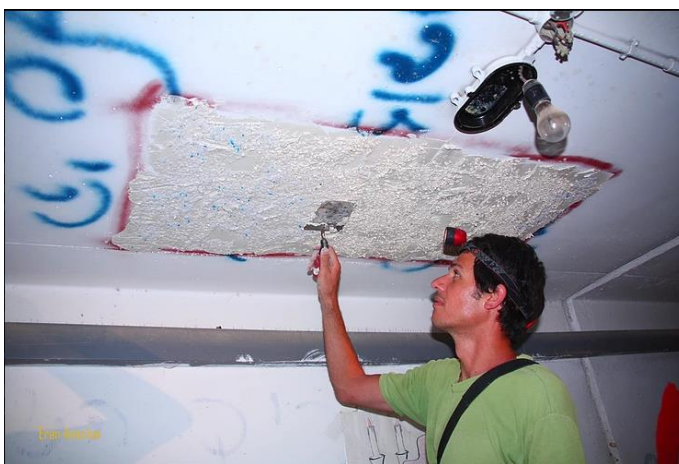
Figure 28. Roughing up the smooth ceilings

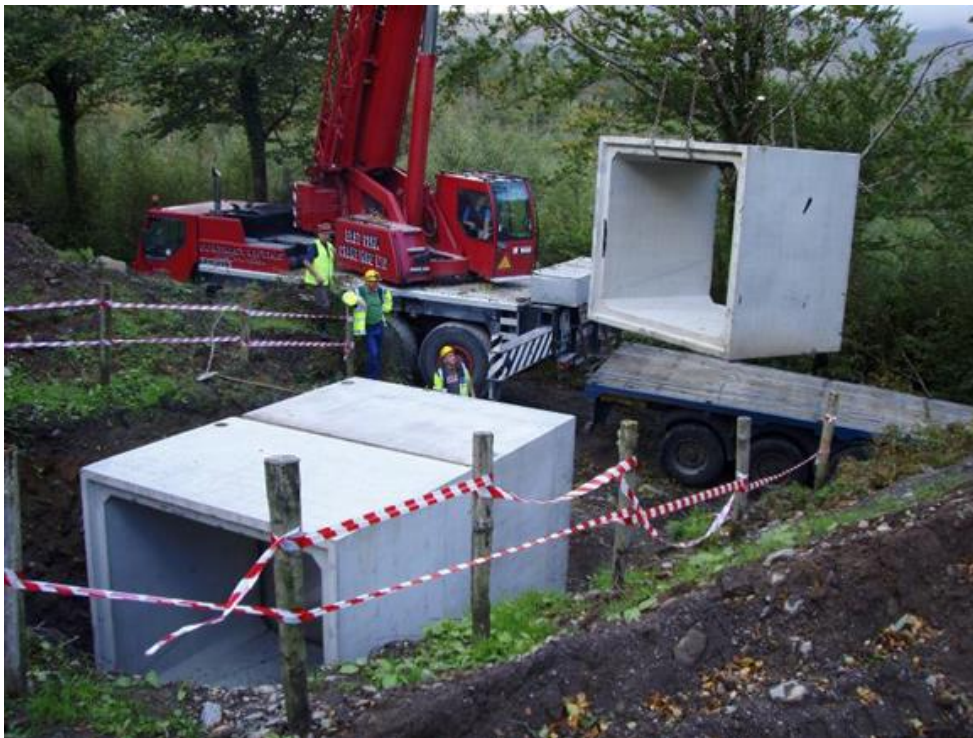
Figure 30. Square profile pre-cast concrete sections being loaded into place.

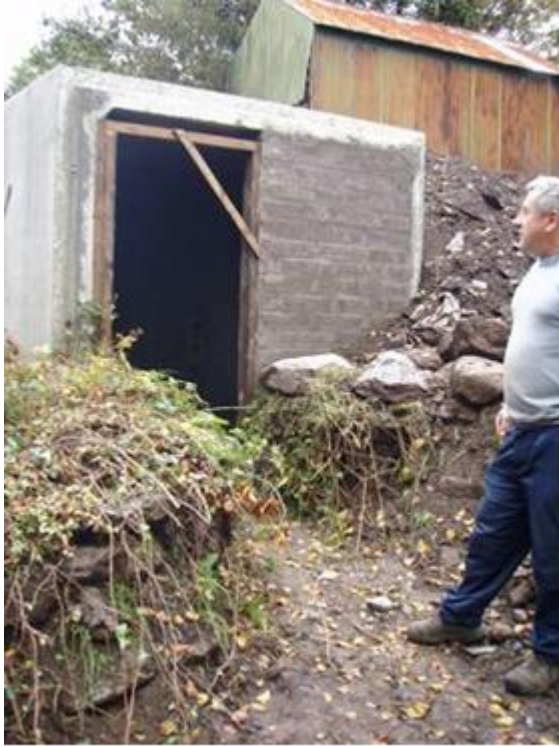
Figure 31. The new hibernation site before it was covered in earth

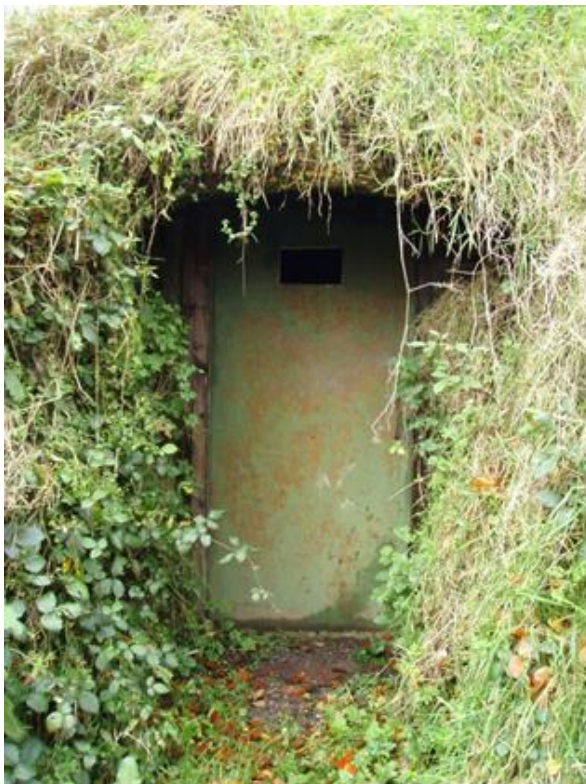
Figure 31. The entrance to the completed structure

The structure had a door with a window to allow the bats access and was covered with earth and vegetation to provide insulation. The new hibernation site was a great success and in the five years following its construction the number of *R. hipposideros* using the site increased to two hundred.

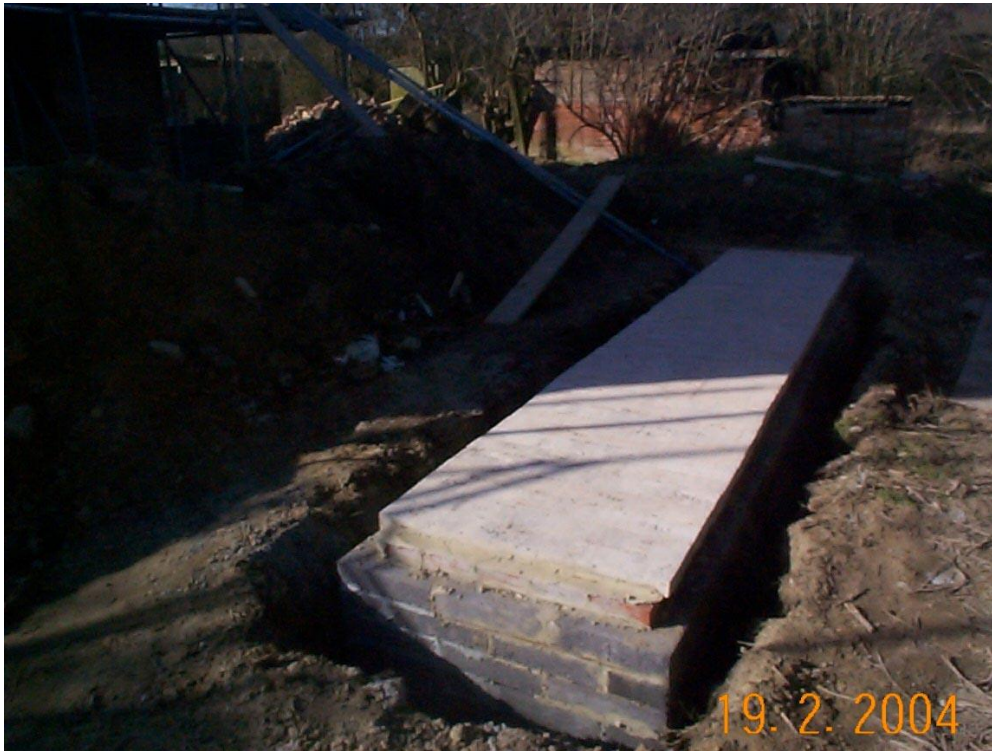
Figure 33. Part of the blockwork tunnel system connected to the maternity roost before it was covered over with earth

The tunnel ended in a small chamber where most of the bats hibernate. A small chimney at the end of one of the tunnels maintains some airflow through the system and holes in the blockwork walls allow some water ingress and keep the humidity levels high.

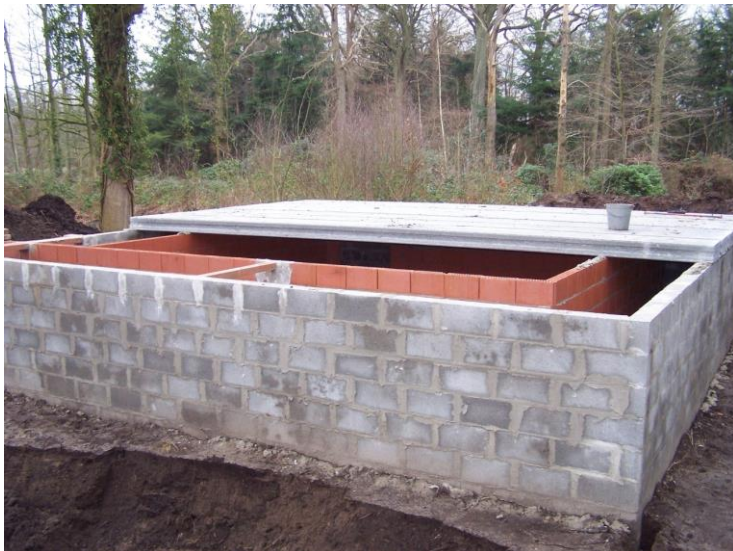
Figure 35. Showing the solid concrete walls and the lighter internal one.

The outside walls of the structure are made of concrete blocks, the inner walls of lightweight building blocks.

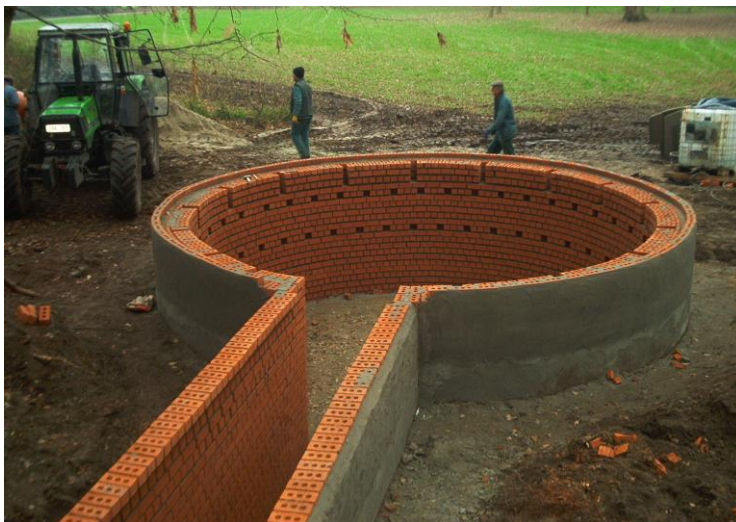
Figure 37. The Bulskampbeld hibernation site part way through construction building a brick dome on the chamber.

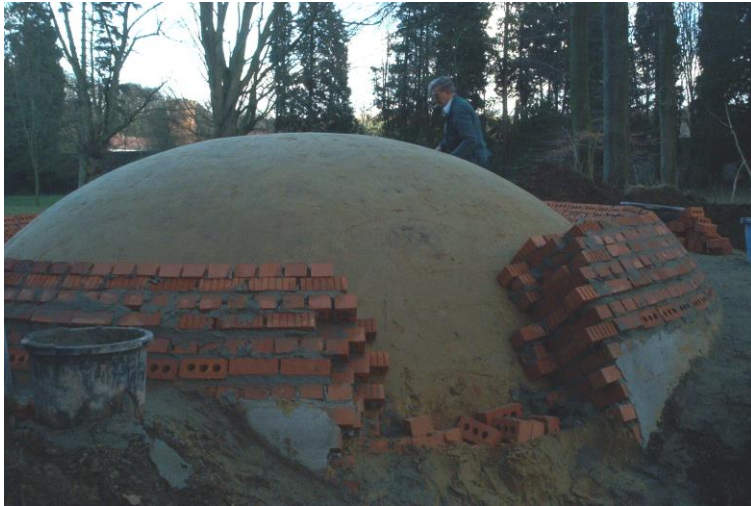
Figure 38. The brick dome being built over the straw and sand forma.

When the dome was complete the straw and sand was removed from the inside of the chamber. The structure was then covered with earth and planted up.
